General Information

Make	Toyota	Model	Innova
YOM	2024	Odo Meter Reading	33,157
Registration No.	DBO7252	Chassis No.	PA2AA8EM5R0141736
CC	2.8	Transmission	A/T
Fuel Type	Diesel	Type of Body	Wagon
Colour	Silver

Body / Panel Condition

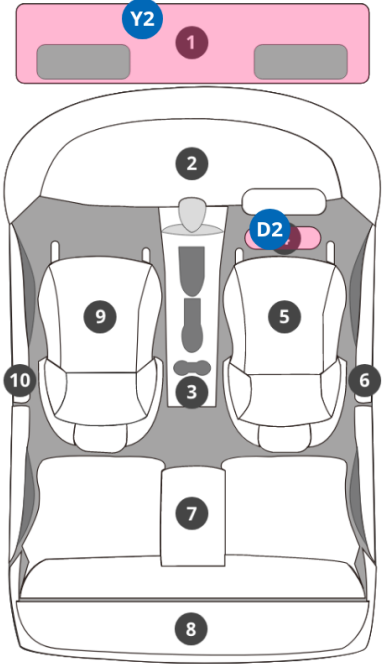
Interior Evaluation : A	Exterior Evaluation : B

<p>a : Cut, Fray d : Loose, Deformed k : Animal Hair s : Smell t : Cigarette Burns x : Defective y : Stain</p>

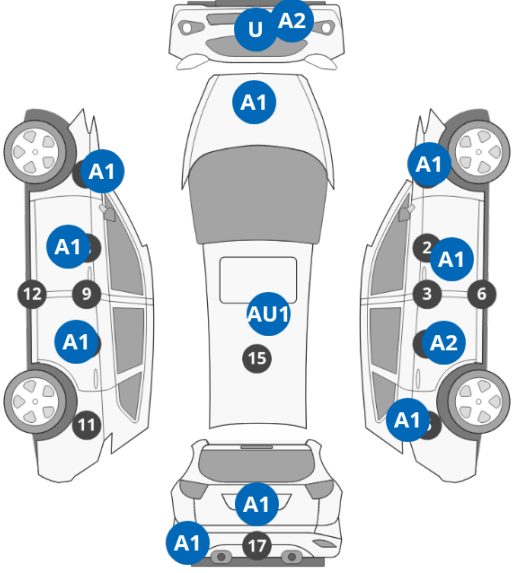
<p>A : Scratch AU : Scratch & Dent B : Modified C : Corrosion G : Stone chip P : Faded S : Rust SC : Rust & Corrosion U : Dent X : Defective Y : Crack, Gap</p>
<p>Remarks (L) Front Floor Mat - Worked - Small / Ceiling - Grime - Small</p>	<p>Remarks Member (Bolted) - Dent - Yes / (R) Rear Fender, Molding - Scratch - Minimal / Trunk Hood, Rear Gate - Scratch - Minimal / Rear Bumper, Lamps, Panels - Scratch - Minimal / Roof - Scratch & Dent - Minimal / (L) Rear Door, Molding - Scratch - Minimal / (L) Front Door, Molding - Scratch - Minimal / (L) Front Fender, Molding - Scratch - Minimal / (R) Front Fender, Molding - Scratch - Minimal / Front Bumper, Grille, Lamps - Scratch - Small / Bonnet, Headlight - Scratch - Minimal / (R) Rear Door, Molding - Scratch - Small / (R) Front Door, Molding - Scratch - Minimal</p>
