General Information

Make	Mitsubishi	Model	Mirage
YOM	2024	Odo Meter Reading	14,067
Registration No.	DBF9223	Chassis No.	PAEA13TJRRRA029065
CC	1.2	Transmission	CVT
Fuel Type	Gas	Type of Body	Sedan
Colour	Red

Body / Panel Condition

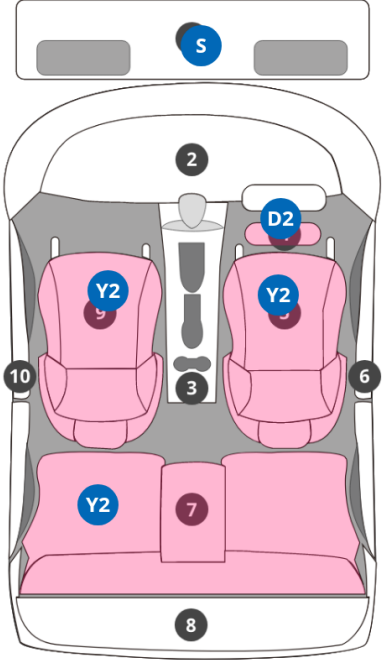
Interior Evaluation : B	Exterior Evaluation : C

<p>a : Cut, Fray d : Loose, Deformed k : Animal Hair s : Smell t : Cigarette Burns x : Defective y : Stain</p>

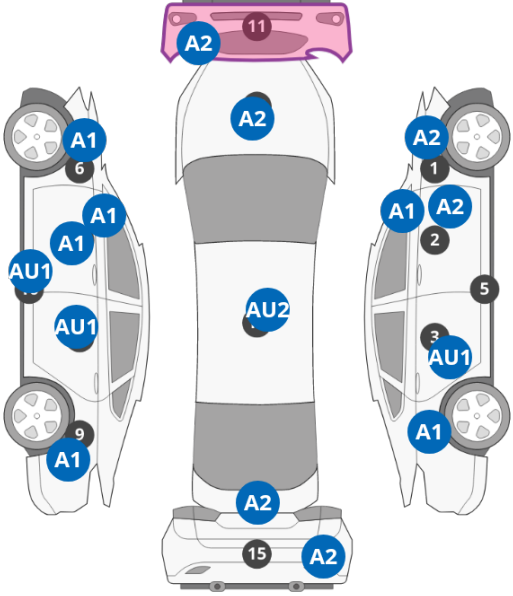
<p>A : Scratch AU : Scratch & Dent B : Modified C : Corrosion G : Stone chip P : Faded S : Rust SC : Rust & Corrosion U : Dent X : Defective Y : Crack, Gap</p>
Remarks (L) Front Floor Mat - Worked - Small / (R) Front Seat - Grime - Small / (L) Front Seat - Grime - Small / Rear Seat - Grime - Small / Overall Interior - Smell - Yes	Remarks (L) Rear Fender - Repair Traces - Yes / Front Bumper, Grille, Lamps - Repair mark - Yes / Front Bumper, Grille, Lamps - Scratch - Small / (R) Front Fender, Molding - Scratch - Small / (R) Front Door, Molding - Scratch - Small / (R) Rear Door, Molding - Scratch & Dent - Minimal / (R) Rear Fender, Molding - Scratch - Minimal / (R) Mirror - Scratch - Minimal / Bonnet, Headlight - Scratch - Small / Rear Bumper, Lamps, Panels - Scratch - Small / Trunk Hood, Rear Gate - Scratch - Small / (L) Rear Fender, Molding - Scratch - Minimal / (L) Rear Door, Molding - Scratch & Dent - Minimal / (L) Front Door, Molding - Scratch - Minimal / (L) Step, In-panel, Side Spoiler - Scratch & Dent - Minimal / (L) Front Fender, Molding - Scratch - Minimal / (L) Mirror - Scratch - Minimal / Roof - Scratch & Dent - Small
