General Information

Make	Toyota	Model	Vios
YOM	2024	Odo Meter Reading	9,671
Registration No.	CAZ8438	Chassis No.	PA1B18F32P4238414
CC	1.3	Transmission	CVT
Fuel Type	Gas	Type of Body	Sedan
Colour	White

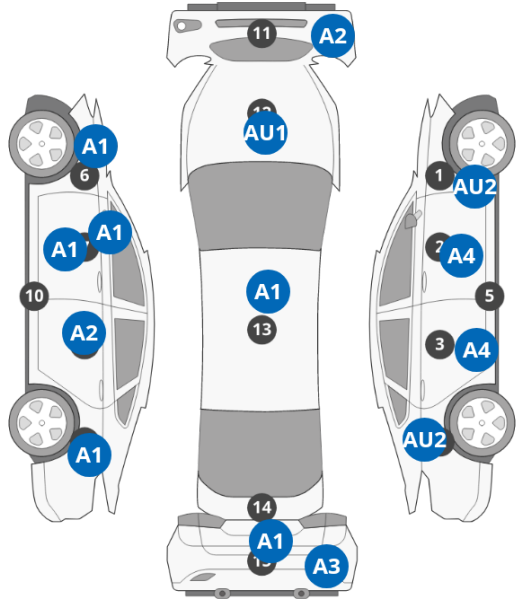
<p>A : Scratch AU : Scratch & Dent B : Modified C : Corrosion G : Stone chip P : Faded S : Rust SC : Rust & Corrosion U : Dent X : Defective Y : Crack, Gap</p>
Remarks Defects not found	Remarks (R) Rear Door, Molding - Scratch - Large / (R) Front Door, Molding - Scratch - Large / (R) Front Fender, Molding - Scratch & Dent - Small / (R) Rear Fender, Molding - Scratch & Dent - Small / Trunk Hood, Rear Gate - Scratch - Minimal / Rear Bumper, Lamps, Panels - Scratch - Medium / (L) Rear Fender, Molding - Scratch - Minimal / (L) Rear Door, Molding - Scratch - Small / (L) Front Door, Molding - Scratch - Minimal / (L) Front Fender, Molding - Scratch - Minimal / (L) Mirror - Scratch - Minimal / Front Bumper, Grille, Lamps - Scratch - Small / Bonnet, Headlight - Scratch & Dent - Minimal / Roof - Scratch - Minimal

Inspector Notes
With LTO plate and Sparetire and Jack and Incomplete Tools, No warranty booklet, No spare key, no reverse camera, scratch headlight and tail light.
