General Information

Make	Toyota	Model	Innova
YOM	2024	Odo Meter Reading	29,246
Registration No.	FAR1885	Chassis No.	PA2JA8EM5P0134900
CC	2.8	Transmission	A/T
Fuel Type	Diesel	Type of Body	Wagon
Colour	Red

Body / Panel Condition

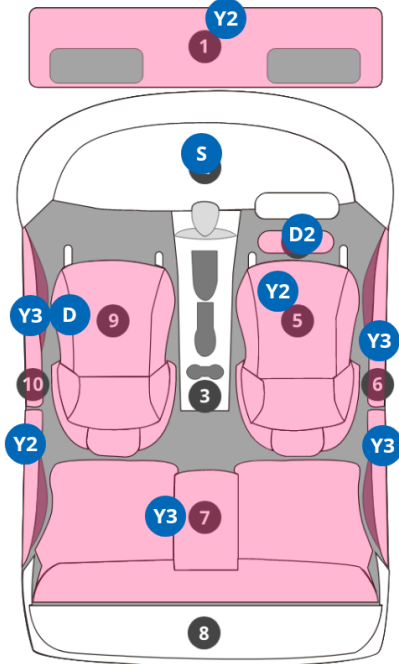
Interior Evaluation : C	Exterior Evaluation : D

<p>a : Cut, Fray d : Loose, Deformed k : Animal Hair s : Smell t : Cigarette Burns x : Defective y : Stain</p>

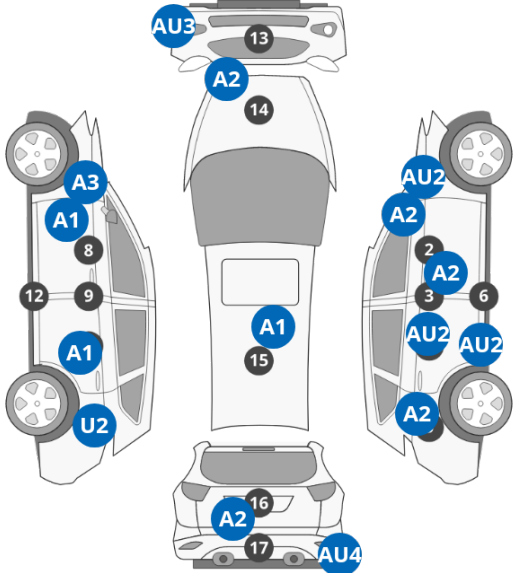
<p>A : Scratch AU : Scratch & Dent B : Modified C : Corrosion G : Stone chip P : Faded S : Rust SC : Rust & Corrosion U : Dent X : Defective Y : Crack, Gap</p>
<p>Remarks (L) Front Seat - Worn - Yes / Overall Interior - Smell - Yes / (L) Front Floor Mat - Worked - Small / (R) Front Trim - Grime - Medium / (R) Rear Trim - Grime - Medium / (L) Rear Trim - Grime - Small / Rear Seat - Grime - Medium / (R) Front Seat - Grime - Small / (L) Front Trim - Grime - Medium / Ceiling - Grime - Small</p>	<p>Remarks (R) Mirror - Scratch - Small / (R) Front Fender, Molding - Scratch & Dent - Small / (R) Step, In-panel, Side Spoiler - Scratch & Dent - Small / (R) Front Door, Molding - Scratch - Small / (R) Rear Door, Molding - Scratch & Dent - Small / (R) Rear Fender, Molding - Scratch - Small / Rear Bumper, Lamps, Panels - Scratch & Dent - Large / Trunk Hood, Rear Gate - Scratch - Small / (L) Rear Fender, Molding - Dent - Small / (L) Rear Door, Molding - Scratch - Minimal / (L) Front Door, Molding - Scratch - Minimal / (L) Front Fender, Molding - Scratch - Medium / Front Bumper, Grille, Lamps - Scratch & Dent - Medium / Bonnet, Headlight - Scratch - Small / Roof - Scratch - Minimal</p>
