General Information

Make	Toyota	Model	Avanza
YOM	2025	Odo Meter Reading	16,048
Registration No.	FAR8740	Chassis No.	MHFAA1BY1R0029342
CC	1.3	Transmission	M/T
Fuel Type	Gas	Type of Body	MPV
Colour	Black

Body / Panel Condition

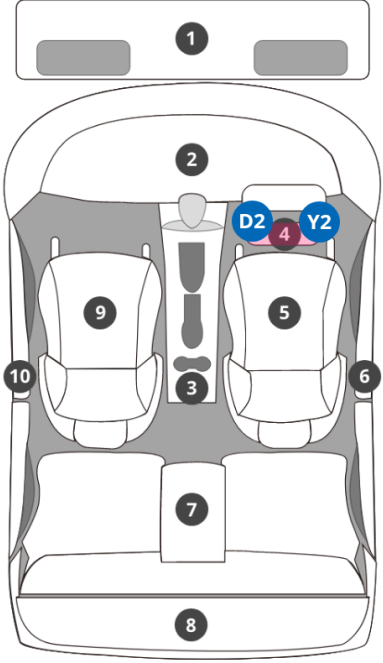
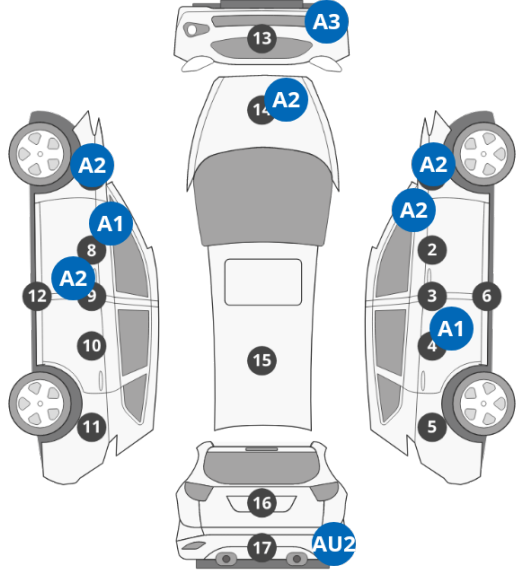
Interior Evaluation :	A	Exterior Evaluation :	B

<p>a : Cut, Fray d : Loose, Deformed k : Animal Hair s : Smell t : Cigarette Burns x : Defective y : Stain</p>		<p>A : Scratch AU : Scratch & Dent B : Modified C : Corrosion G : Stone chip P : Faded S : Rust SC : Rust & Corrosion U : Dent X : Defective Y : Crack, Gap</p>	
<p>Remarks (L) Front Floor Mat - Worked - Small / (R) Front Floor Mat - Grime - Small</p>		<p>Remarks Bonnet, Headlight - Scratch - Small / (L) Mirror - Scratch - Minimal / (L) Front Fender, Molding - Scratch - Small / (L) Front Door, Molding - Scratch - Small / (R) Rear Door, Molding - Scratch - Minimal / Rear Bumper, Lamps, Panels - Scratch & Dent - Small / (R) Mirror - Scratch - Small / (R) Front Fender, Molding - Scratch - Small / Front Bumper, Grille, Lamps - Scratch - Medium</p>	
Frame Evaluation :	A	Functional Evaluation :	C
<p>Remarks Defects not found</p>		<p>Remarks Warning Lamps - Issue - Yes / Battery - Weak - Yes / Spare Key - Issue - Unexist</p>
