## General Information

| Make | Toyota | Model | Avanza |
| Registration No. | NFC9365 | Chassis No. | MHFA1BYXP0016800 |

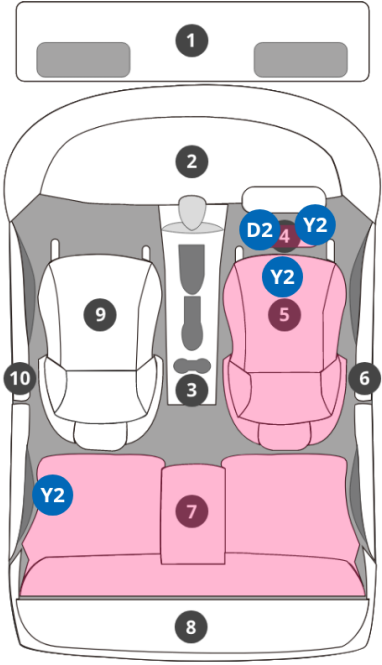
| Interior Evaluation : <span style="color: red;">A</span> | Exterior Evaluation : <span style="color: red;">D</span> |
|---|---|
| <b>Remarks</b><br>(R) Front Seat - Grime - Small / (R) Front Floor Mat - Grime - Small / Rear Seat - Grime - Small / (L) Front Floor Mat - Worked - Small | <b>Remarks</b><br>(R) Front Fender - Repair Traces - Yes / Bonnet - Repair Traces - Yes / (L) Front Fender - Repair Traces - Yes / Bonnet, Headlight - Scratch - Large / (R) Front Door, Molding - Scratch - Minimal / (R) Rear Door, Molding - Scratch - Small / (R) Rear Fender, Molding - Scratch - Small / Rear Windshield - Scratch, Stone chip - Medium / Rear Bumper, Lamps, Panels - Scratch - Medium / (L) Rear Fender, Molding - Scratch - Small / (L) Rear Door, Molding - Scratch - Large / (L) Front Door, Molding - Scratch - Small / (L) Front Fender, Molding - Scratch - Small / Front Bumper, Grille, Lamps - Scratch - Small / Roof - Scratch - Small |
