General Information

Make	Toyota	Model	Wigo
YOM	2022	Odo Meter Reading	38,475
Registration No.	DAP9285	Chassis No.	MHKA4DF5FNJ065751
CC	1.0	Transmission	A/T
Fuel Type	Gas	Type of Body	Hatchback
Colour	Gray

Body / Panel Condition

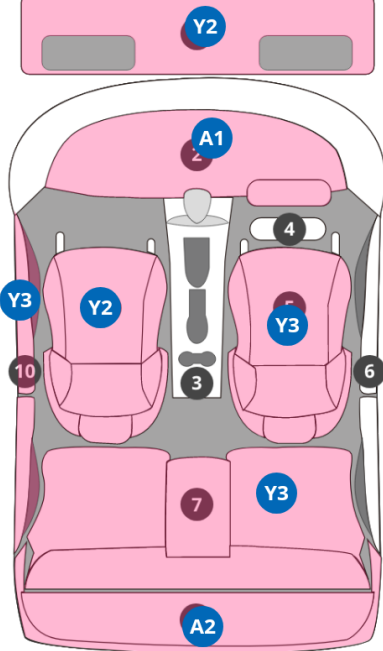
Interior Evaluation : C	Exterior Evaluation : E

<p>a : Cut, Fray d : Loose, Deformed k : Animal Hair s : Smell t : Cigarette Burns x : Defective y : Stain</p>

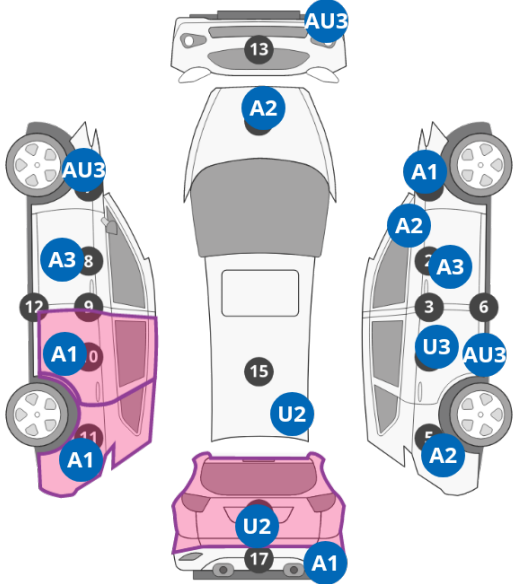
<p>A : Scratch AU : Scratch & Dent B : Modified C : Corrosion G : Stone chip P : Faded S : Rust SC : Rust & Corrosion U : Dent X : Defective Y : Crack, Gap</p>
<p>Remarks Trunk Room - Worn, Scratch, Cut, Crack - Small / Rear Seat - Grime - Medium / (R) Front Seat - Grime - Medium / (L) Front Trim - Grime - Medium / (L) Front Seat - Grime - Small / Ceiling - Grime - Small / Dashboard - Worn, Scratch, Cut, Crack - Minimal</p>	<p>Remarks Bonnet - Repair Traces - Yes / (L) Front Fender - Repair Traces - Yes / (L) Rear Door - Repair Traces - Yes / (L) Rear Fender - Repair Traces - Yes / Trunk Hood, Rear Gate - Repair Traces - Yes / Roof - Repair Traces - Yes / Roof - Dent - Small / Trunk Hood, Rear Gate - Dent - Small / (R) Front Fender, Molding - Scratch - Minimal / (R) Mirror - Scratch - Small / (R) Front Door, Molding - Scratch - Medium / (R) Step, In-panel, Side Spoiler - Scratch & Dent - Medium / (R) Rear Door, Molding - Dent - Medium / (R) Rear Fender, Molding - Scratch - Small / Rear Bumper, Lamps, Panels - Scratch - Minimal / (L) Rear Fender, Molding - Scratch - Minimal / (L) Rear Door, Molding - Scratch - Minimal / (L) Front Door, Molding - Scratch - Medium / (L) Front Fender, Molding - Scratch & Dent - Medium / Bonnet, Headlight - Scratch - Small / Front Bumper, Grille, Lamps - Scratch & Dent - Medium / Trunk Hood, Rear Gate - Repair mark - Yes / (L) Rear Fender, Molding - Repair mark - Yes / (L) Rear Door, Molding - Repair mark - Yes</p>
