General Information

Make	Toyota	Model	Vios
YOM	2023	Odo Meter Reading	139,096
Registration No.	DAS5404	Chassis No.	PA1B18F30N4192658
CC	1.3	Transmission	CVT
Fuel Type	Gas	Type of Body	Sedan
Colour	Red

Body / Panel Condition

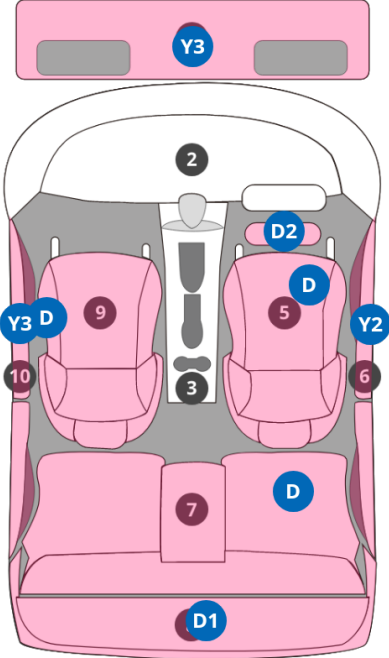
Interior Evaluation : C	Exterior Evaluation : D

<p>a : Cut, Fray d : Loose, Deformed k : Animal Hair s : Smell t : Cigarette Burns x : Defective y : Stain</p>

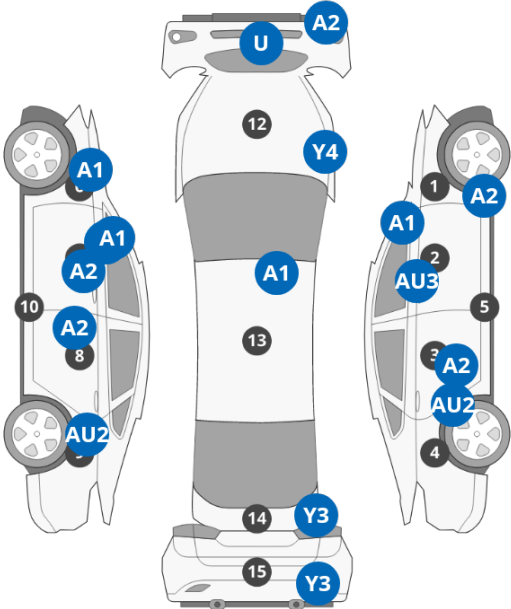
<p>A : Scratch AU : Scratch & Dent B : Modified C : Corrosion G : Stone chip P : Faded S : Rust SC : Rust & Corrosion U : Dent X : Defective Y : Crack, Gap</p>
<p>Remarks (L) Front Floor Mat - Worked - Small / (L) Front Seat - Worn - Yes / (R) Front Seat - Worn - Yes / Rear Seat - Worn - Yes / Ceiling - Grime - Medium / (R) Front Trim - Grime - Small / Trunk Room - Worked - Minimal / (L) Front Trim - Grime - Medium</p>	<p>Remarks (R) Mirror - Scratch - Minimal / (R) Front Fender, Molding - Scratch - Small / (R) Front Door, Molding - Scratch & Dent - Medium / (R) Rear Door, Molding - Scratch - Small / (R) Rear Fender, Molding - Scratch & Dent - Small / Rear Bumper, Lamps, Panels - Crack, Gap - Medium / Trunk Hood, Rear Gate - Crack, Gap - Medium / (L) Rear Fender, Molding - Scratch & Dent - Small / (L) Rear Door, Molding - Scratch - Small / (L) Front Door, Molding - Scratch - Small / (L) Mirror - Stuck - Yes / (L) Mirror - Scratch - Minimal / (L) Front Fender, Molding - Scratch - Minimal / Member (Bolted) - Dent - Yes / Front Bumper, Grille, Lamps - Scratch - Small / Roof - Scratch - Minimal / Bonnet, Headlight - Crack, Gap - Large</p>

<p>Inspector Notes</p>
<p>no warranty booklet, with jack, no tools, with spare tire, with LTO plate, scratched and cracked tail light, headlight and park light missing, front bumper partially missing, front signal light missing, trunk floormat/cover missing, engine abnormal noise</p>
