General Information

Make	Toyota	Model	Innova
YOM	2022	Odo Meter Reading	48,891
Registration No.	DBG2943	Chassis No.	PA2JA8EM5N0112683
CC	2.8	Transmission	A/T
Fuel Type	Diesel	Type of Body	Wagon
Colour	Red

Body / Panel Condition

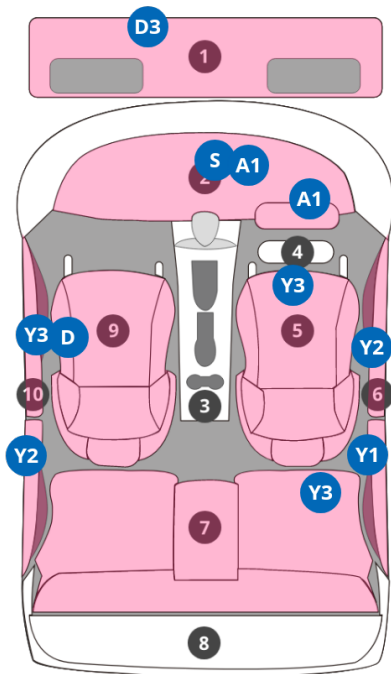
<p>a : Cut, Fray d : Loose, Deformed k : Animal Hair s : Smell t : Cigarette Burns x : Defective y : Stain</p>

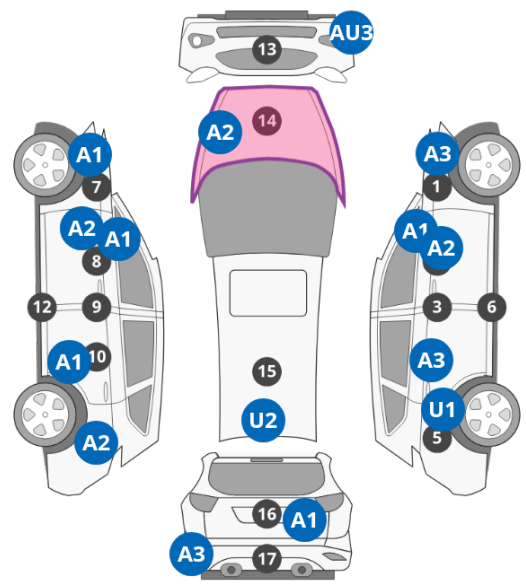
<p>A : Scratch AU : Scratch & Dent B : Modified C : Corrosion G : Stone chip P : Faded S : Rust SC : Rust & Corrosion U : Dent X : Defective Y : Crack, Gap</p>
<p>Remarks Overall Interior - Smell - Yes / (L) Front Trim - Grime - Medium / (L) Rear Trim - Grime - Small / (R) Rear Trim - Grime - Minimal / (R) Front Trim - Grime - Small / (L) Front Seat - Worn - Yes / (R) Front Seat - Grime - Medium / Rear Seat - Grime - Medium / Dashboard - Worn, Scratch, Cut, Crack - Minimal / Glove Box - Worn, Scratch, Cut, Crack - Minimal / Ceiling - Crinkle - Medium</p>	<p>Remarks (R) Front Fender - Repair Traces - Yes / Bonnet - Repair Traces - Yes / (L) Front Fender - Repair Traces - Yes / (L) Front Door - Repair Traces - Yes / (R) Front Fender, Molding - Scratch - Medium / (R) Mirror - Scratch - Minimal / (R) Front Door, Molding - Scratch - Small / (R) Rear Door, Molding - Scratch - Medium / (R) Rear Fender, Molding - Dent - Minimal / Rear Bumper, Lamps, Panels - Scratch - Medium / Trunk Hood, Rear Gate - Scratch - Minimal / (L) Rear Fender, Molding - Scratch - Small / (L) Rear Door, Molding - Scratch - Minimal / (L) Front Door, Molding - Scratch - Small / (L) Mirror - Scratch - Minimal / (L) Front Fender, Molding - Scratch - Minimal / Front Bumper, Grille, Lamps - Scratch & Dent - Medium / Bonnet, Headlight - Repair mark - Yes / Bonnet, Headlight - Scratch - Small / Roof - Dent - Small</p>
