## General Information

<b>Make</b>	Toyota	<b>Model</b>	Vios
<b>YOM</b>	2024	<b>Odo Meter Reading</b>	22,511
<b>Registration No.</b>	DBJ7128	<b>Chassis No.</b>	PA1B18F32P4226425
<b>CC</b>	1.3	<b>Transmission</b>	CVT
<b>Fuel Type</b>	Gas	<b>Type of Body</b>	Sedan
<b>Colour</b>	Red

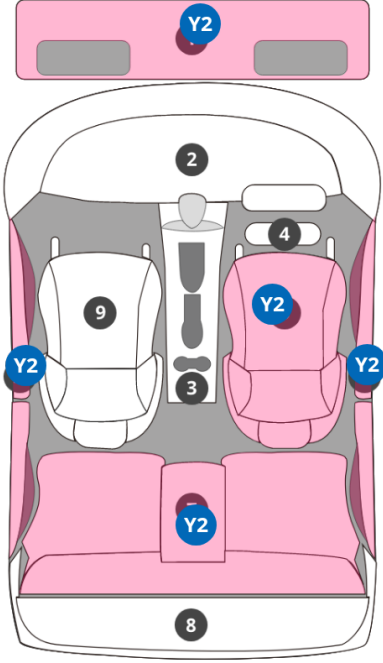
<b>Interior Evaluation :</b> <span style="float: right;"><b>B</b></span>	<b>Exterior Evaluation :</b> <span style="float: right;"><b>C</b></span>

<p><b>a</b> : Cut, Fray <b>d</b> : Loose, Deformed <b>k</b> : Animal Hair <b>s</b> : Smell <b>t</b> : Cigarette Burns <b>x</b> : Defective <b>y</b> : Stain</p>

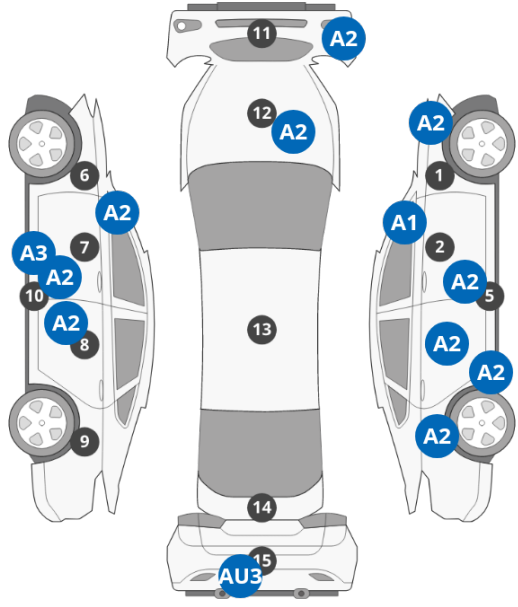
<p><b>A</b> : Scratch <b>AU</b> : Scratch &amp; Dent <b>B</b> : Modified <b>C</b> : Corrosion <b>G</b> : Stone chip <b>P</b> : Faded <b>S</b> : Rust <b>SC</b> : Rust &amp; Corrosion <b>U</b> : Dent <b>X</b> : Defective <b>Y</b> : Crack, Gap</p>
<p><b>Remarks</b> Ceiling - Grime - Small / (R) Front Trim - Grime - Small / (R) Front Seat - Grime - Small / Rear Seat - Grime - Small / (L) Front Trim - Grime - Small</p>	<p><b>Remarks</b> (L) Rear Door, Molding - Scratch - Small / (L) Front Door, Molding - Scratch - Small / (L) Mirror - Scratch - Small / (L) Step, In-panel, Side Spoiler - Scratch - Medium / Bonnet, Headlight - Scratch - Small / (R) Front Fender, Molding - Scratch - Small / Front Bumper, Grille, Lamps - Scratch - Small / (R) Mirror - Scratch - Minimal / (R) Front Door, Molding - Scratch - Small / (R) Rear Fender, Molding - Scratch - Small / (R) Step, In-panel, Side Spoiler - Scratch - Small / (R) Rear Door, Molding - Scratch - Small / Rear Bumper, Lamps, Panels - Scratch &amp; Dent - Medium</p>
