General Information

Make	Toyota	Model	Wigo
YOM	2024	Odo Meter Reading	39,333
Registration No.	DBP8277	Chassis No.	MHKAA1BC8RJ021710
CC	1.0	Transmission	CVT
Fuel Type	Gas	Type of Body	Hatchback
Colour	Silver

Body / Panel Condition

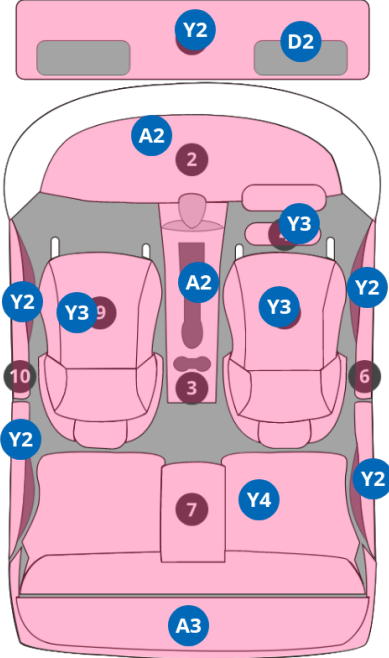
Interior Evaluation : E	Exterior Evaluation : E

<p>a : Cut, Fray d : Loose, Deformed k : Animal Hair s : Smell t : Cigarette Burns x : Defective y : Stain</p>

<p>A : Scratch AU : Scratch & Dent B : Modified C : Corrosion G : Stone chip P : Faded S : Rust SC : Rust & Corrosion U : Dent X : Defective Y : Crack, Gap</p>
<p>Remarks Rear Seat - Grime - Large / (R) Front Seat - Grime - Medium / (R) Front Trim - Grime - Small / (R) Rear Trim - Grime - Small / Trunk Room - Worn, Scratch, Cut, Crack - Medium / (L) Rear Trim - Grime - Small / (L) Front Trim - Grime - Small / (L) Front Seat - Grime - Medium / (L) Front Floor Mat - Grime - Medium / Console, Switches, Vents - Worn, Scratch, Cut, Crack - Small / Ceiling - Grime - Small / Dashboard - Worn, Scratch, Cut, Crack - Small / Sunvisor, Sunglass Holder - Loose, Deformed - Small</p>	<p>Remarks (R) Step, In-panel, Side Spoiler - Scratch & Dent - Large / (R) Rear Door, Molding - Scratch - Large / (R) Rear Fender, Molding - Scratch - Medium / (R) Front Door, Molding - Scratch & Dent - Medium / (R) Mirror - Scratch - Minimal / (R) Front Fender, Molding - Scratch - Medium / Bonnet, Headlight - Scratch & Dent - Medium / Front Bumper, Grille, Lamps - Scratch & Dent - Medium / (L) Front Fender, Molding - Scratch - Medium / (L) Front Door, Molding - Scratch - Large / (L) Rear Door, Molding - Scratch - Large / (L) Rear Fender, Molding - Scratch - Medium / Trunk Hood, Rear Gate - Scratch - Medium / Rear Bumper, Lamps, Panels - Scratch - Medium / (L) Mirror - Scratch - Small / Roof - Scratch - Minimal / (L) Step, In-panel, Side Spoiler - Scratch - Medium</p>
