General Information

Make	Toyota	Model	Wigo
YOM	2021	Odo Meter Reading	52,702
Registration No.	NGL8863	Chassis No.	MHKA4DF5FMJ053110
CC	1.0	Transmission	A/T
Fuel Type	Gas	Type of Body	Hatchback
Colour	White

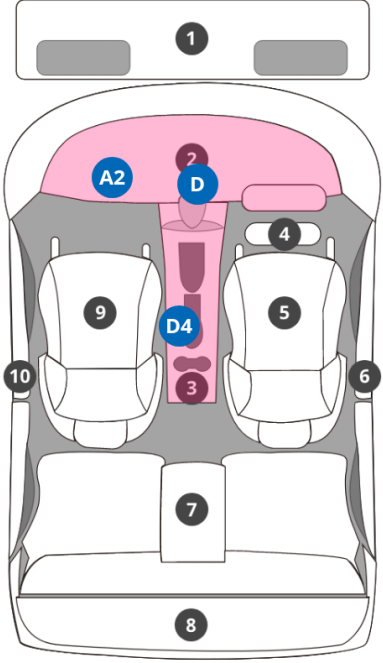
Interior Evaluation : C	Exterior Evaluation : E

<p>a : Cut, Fray d : Loose, Deformed k : Animal Hair s : Smell t : Cigarette Burns x : Defective y : Stain</p>

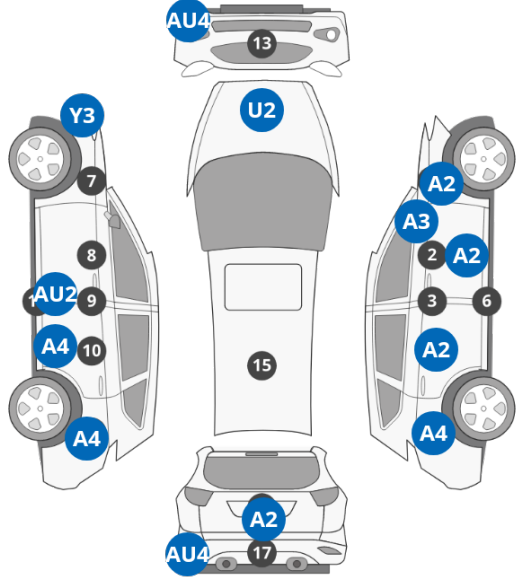
<p>A : Scratch AU : Scratch & Dent B : Modified C : Corrosion G : Stone chip P : Faded S : Rust SC : Rust & Corrosion U : Dent X : Defective Y : Crack, Gap</p>
<p>Remarks Console, Switches, Vents - Loose, Deformed - Large / Dashboard - Traces of Adhesive Tape - Yes / Overall Interior - Worn as per age - Yes / Steering Wheel - Worn, Peel, Crack - Small</p>	<p>Remarks Front Bumper, Grille, Lamps - Scratch & Dent - Large / (L) Front Fender, Molding - Crack, Gap - Medium / (L) Rear Fender, Molding - Scratch - Large / (L) Rear Door, Molding - Scratch - Large / (L) Front Door, Molding - Scratch & Dent - Small / Rear Bumper, Lamps, Panels - Scratch & Dent - Large / Trunk Hood, Rear Gate - Scratch - Small / (R) Rear Fender, Molding - Scratch - Large / (R) Rear Door, Molding - Scratch - Small / (R) Front Door, Molding - Scratch - Small / (R) Front Fender, Molding - Scratch - Small / (R) Mirror - Scratch - Medium / Bonnet, Headlight - Dent - Small</p>
