## General Information

<b>Make</b>	Toyota	<b>Model</b>	Vios
<b>YOM</b>	2022	<b>Odo Meter Reading</b>	29,055
<b>Registration No.</b>	NIB8987	<b>Chassis No.</b>	PA1B18F31N4180468
<b>CC</b>	1.3	<b>Transmission</b>	CVT
<b>Fuel Type</b>	Gas	<b>Type of Body</b>	Sedan
<b>Colour</b>	Green

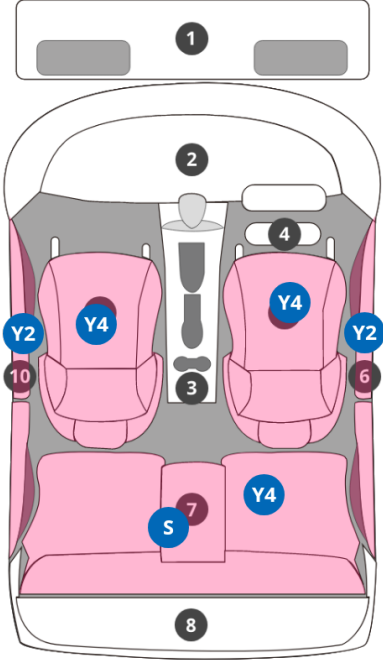
<b>Interior Evaluation :</b> <span style="float: right; color: red; font-weight: bold;">C</span>	<b>Exterior Evaluation :</b> <span style="float: right; color: red; font-weight: bold;">E</span>

<p><b>a</b> : Cut, Fray <b>d</b> : Loose, Deformed <b>k</b> : Animal Hair <b>s</b> : Smell <b>t</b> : Cigarette Burns <b>x</b> : Defective <b>y</b> : Stain</p>

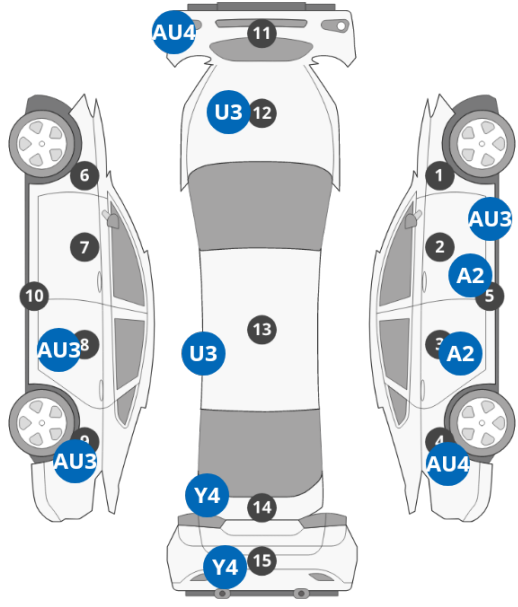
<p><b>A</b> : Scratch <b>AU</b> : Scratch &amp; Dent <b>B</b> : Modified <b>C</b> : Corrosion <b>G</b> : Stone chip <b>P</b> : Faded <b>S</b> : Rust <b>SC</b> : Rust &amp; Corrosion <b>U</b> : Dent <b>X</b> : Defective <b>Y</b> : Crack, Gap</p>
<p><b>Remarks</b> Rear Seat - Grime - Large / Overall Interior - Smell - Yes / (R) Front Seat - Grime - Large / (R) Front Trim - Grime - Small / (L) Front Trim - Grime - Small / (L) Front Seat - Grime - Large</p>	<p><b>Remarks</b> Bonnet, Headlight - Dent - Medium / Front Bumper, Grille, Lamps - Scratch &amp; Dent - Large / (L) Rear Door, Molding - Scratch &amp; Dent - Medium / (L) Rear Fender, Molding - Scratch &amp; Dent - Medium / Roof - Dent - Medium / Rear Bumper, Lamps, Panels - Crack, Gap - Large / Trunk Hood, Rear Gate - Crack, Gap - Large / (R) Rear Fender, Molding - Scratch &amp; Dent - Large / (R) Step, In-panel, Side Spoiler - Scratch &amp; Dent - Medium / (R) Rear Door, Molding - Scratch - Small / (R) Front Door, Molding - Scratch - Small</p>
