General Information

Make	Toyota	Model	Vios
YOM	2011	Odo Meter Reading	117,241
Registration No.	TBI669	Chassis No.	NCP929042625
CC	1.3	Transmission	A/T
Fuel Type	Gas	Type of Body	Sedan
Colour	Black

Body / Panel Condition

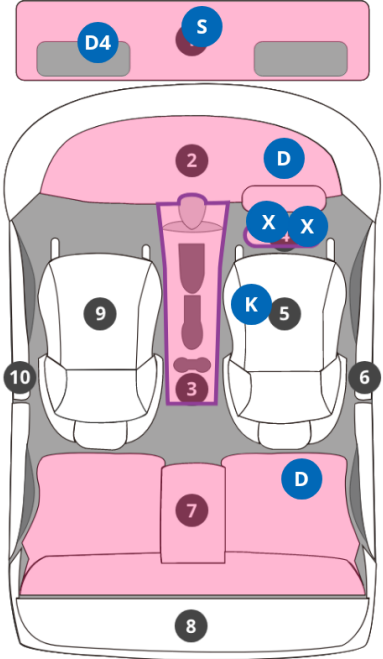
Interior Evaluation : C	Exterior Evaluation : E

<p>a : Cut, Fray d : Loose, Deformed k : Animal Hair s : Smell t : Cigarette Burns x : Defective y : Stain</p>

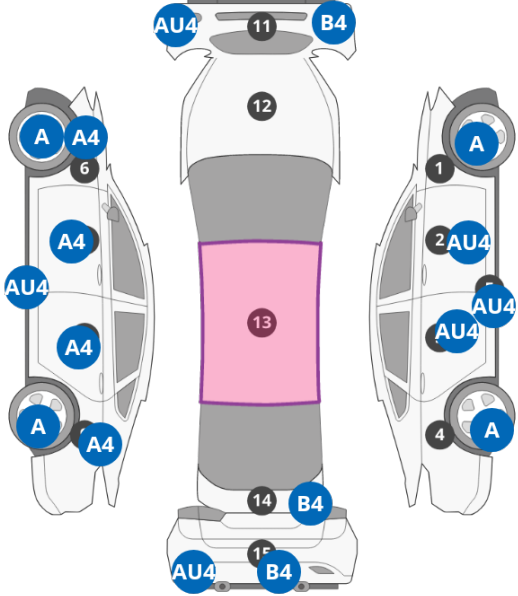
<p>A : Scratch AU : Scratch & Dent B : Modified C : Corrosion G : Stone chip P : Faded S : Rust SC : Rust & Corrosion U : Dent X : Defective Y : Crack, Gap</p>
<p>Remarks Overall Interior - Smell - Yes / Overall Interior - Worn as per age - Yes / Overall Interior - Animal Hair - Yes / Rear Seat - Worn - Yes / Display, Audio System - Missing - Yes / Dashboard - Traces of Adhesive Tape - Yes / (L) Front Floor Mat - Missing - Yes / (R) Front Floor Mat - Missing - Yes / Mat Other - Missing - Yes / Sunvisor, Sunglass Holder - Worked - Large</p>	<p>Remarks (R) Front Door - Repair Traces - Yes / (R) Step - Repair Traces - Yes / (R) Front Fender - Repair Traces - Yes / Bonnet - Repair Traces - Yes / (L) Front Fender - Repair Traces - Yes / (L) Front Door - Repair Traces - Yes / (L) Step - Repair Traces - Yes / (L) Rear Door - Repair Traces - Yes / Trunk Hood, Rear Gate - Repair Traces - Yes / (R) Rear Fender - Repair Traces - Yes / (R) Rear Door - Repair Traces - Yes / Roof - Repair Traces - Yes / Rear Bumper, Lamps, Panels - Scratch & Dent - Large / Rear Bumper, Lamps, Panels - Modified - Large / Trunk Hood, Rear Gate - Modified - Large / (R) Step, In-panel, Side Spoiler - Scratch & Dent - Large / (R) Front Door, Molding - Scratch & Dent - Large / (R) Rear Door, Molding - Scratch & Dent - Large / Front Bumper, Grille, Lamps - Scratch & Dent - Large / Front Bumper, Grille, Lamps - Modified - Large / (R) Front Tyre - Crack, Cut - Yes / (R) Rear Tyre - Crack, Cut - Yes / (L) Front Tyre - Crack, Cut - Yes / (L) Rear Tyre - Crack, Cut - Yes / (L) Front Fender, Molding - Scratch - Large / (L) Step, In-panel, Side Spoiler - Scratch & Dent - Large / (L) Front Door, Molding - Scratch - Large / (L) Rear Door, Molding - Scratch - Large / (L) Rear Fender, Molding - Scratch - Large / Front Windshield - Damaged - Repair mark</p>
