General Information

Make	Toyota	Model	Vios
YOM	2024	Odo Meter Reading	9,657
Registration No.	DBF6349	Chassis No.	PA1B18F31R4246068
CC	1.3	Transmission	CVT
Fuel Type	Gas	Type of Body	Sedan
Colour	Red Mica Metallic

Body / Panel Condition

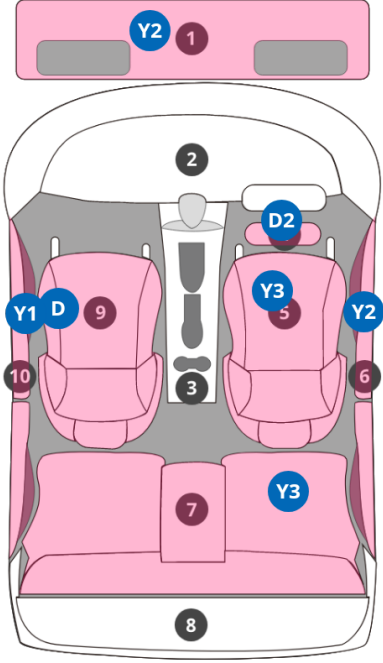
Interior Evaluation : C	Exterior Evaluation : C

<p>a : Cut, Fray d : Loose, Deformed k : Animal Hair s : Smell t : Cigarette Burns x : Defective y : Stain</p>

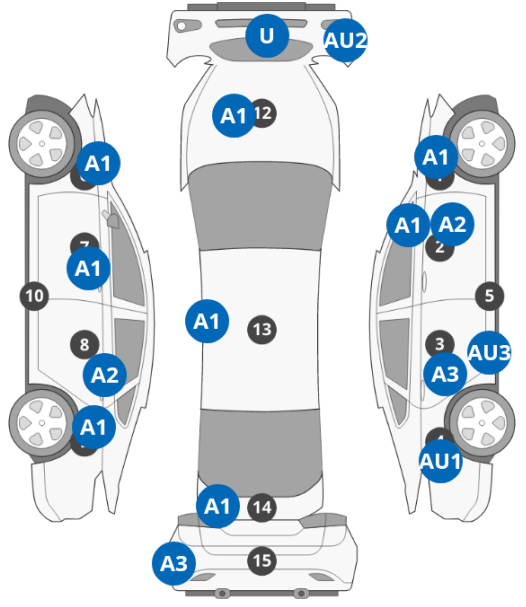
<p>A : Scratch AU : Scratch & Dent B : Modified C : Corrosion G : Stone chip P : Faded S : Rust SC : Rust & Corrosion U : Dent X : Defective Y : Crack, Gap</p>
<p>Remarks (R) Front Seat - Grime - Medium / (L) Front Seat - Worn - Yes / Rear Seat - Grime - Medium / (R) Front Trim - Grime - Small / (L) Front Trim - Grime - Minimal / (L) Front Floor Mat - Worked - Small / Ceiling - Grime - Small</p>	<p>Remarks Member (Bolted) - Dent - Yes / (R) Front Fender, Molding - Scratch - Minimal / (R) Mirror - Scratch - Minimal / (R) Step, In-panel, Side Spoiler - Scratch & Dent - Medium / (R) Front Door, Molding - Scratch - Small / (R) Rear Door, Molding - Scratch - Medium / (R) Rear Fender, Molding - Scratch & Dent - Minimal / Rear Bumper, Lamps, Panels - Scratch - Medium / Trunk Hood, Rear Gate - Scratch - Minimal / (L) Rear Fender, Molding - Scratch - Minimal / (L) Rear Door, Molding - Scratch - Small / (L) Front Door, Molding - Scratch - Minimal / (L) Front Fender, Molding - Scratch - Minimal / Front Bumper, Grille, Lamps - Scratch & Dent - Small / Bonnet, Headlight - Scratch - Minimal / Roof - Scratch - Minimal</p>

<p>Inspector Notes</p>
<p>with warranty booklet, with jack, incomplete tools, with spare tire, with LTO plate, scratched and cracked tail light</p>
