General Information

Make	Toyota	Model	Vios
YOM	2023	Odo Meter Reading	34,194
Registration No.	DBH7272	Chassis No.	PA1B18F34P4208749
CC	1.3	Transmission	CVT
Fuel Type	Gas	Type of Body	Sedan
Colour	Red Mica Metallic

Body / Panel Condition

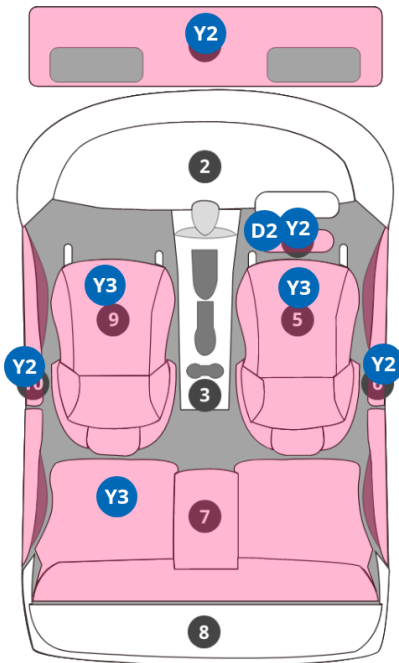
Interior Evaluation : C	Exterior Evaluation : D

<p>a : Cut, Fray d : Loose, Deformed k : Animal Hair s : Smell t : Cigarette Burns x : Defective y : Stain</p>

<p>A : Scratch AU : Scratch & Dent B : Modified C : Corrosion G : Stone chip P : Faded S : Rust SC : Rust & Corrosion U : Dent X : Defective Y : Crack, Gap</p>
<p>Remarks Ceiling - Grime - Small / (R) Front Trim - Grime - Small / (R) Front Seat - Grime - Medium / Rear Seat - Grime - Medium / Mat Other - Grime - Small / (L) Front Seat - Grime - Medium / (L) Front Floor Mat - Worked - Small / (L) Front Trim - Grime - Small</p>	<p>Remarks (L) Rear Door, Molding - Scratch - Large / (L) Rear Fender, Molding - Scratch - Medium / (L) Front Door, Molding - Scratch - Small / (L) Mirror - Scratch - Small / (L) Front Fender, Molding - Scratch - Small / Bonnet, Headlight - Scratch - Minimal / Front Bumper, Grille, Lamps - Scratch & Dent - Medium / (R) Front Door, Molding - Scratch - Small / (R) Rear Door, Molding - Scratch & Dent - Medium / (R) Rear Fender, Molding - Scratch & Dent - Small / Trunk Hood, Rear Gate - Scratch & Dent - Medium / Rear Bumper, Lamps, Panels - Scratch - Small / (R) Front Fender, Molding - Scratch - Minimal</p>
