General Information

Make	Toyota	Model	Hilux Tamaraw
YOM	2025	Odo Meter Reading	11,450
Registration No.	DBT9401	Chassis No.	PAHACACA2S6124310
CC	2.4	Transmission	M/T
Fuel Type	Diesel	Type of Body	Utility Passenger
Colour	White

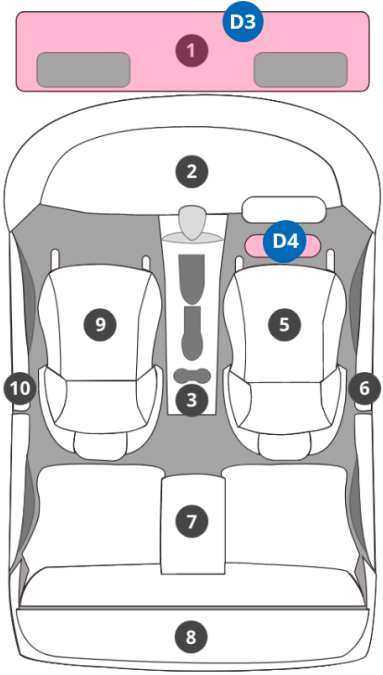
<p>a : Cut, Fray d : Loose, Deformed k : Animal Hair s : Smell t : Cigarette Burns x : Defective y : Stain</p>

<p>A : Scratch AU : Scratch & Dent B : Modified C : Corrosion G : Stone chip P : Faded S : Rust SC : Rust & Corrosion U : Dent X : Defective Y : Crack, Gap</p>
<p>Remarks (R) Front Floor Mat - Grime - Medium / (L) Front Floor Mat - Worked - Large / Ceiling - Crinkle - Medium</p>	<p>Remarks (R) Front Fender, Molding - Scratch - Minimal / (R) Mirror - Scratch - Minimal / (R) Rear Door, Molding - Scratch - Minimal / (R) Side Gate - Scratch - Medium / Rear Bumper, Lamps, Panels - Scratch - Small / Cargo Bed Floor - Scratch & Dent - Large / Cab Back Panel - Scratch - Small / Rear Gate - Scratch - Small / (L) Side Gate - Scratch - Small / (L) Mirror - Scratch - Small / (L) Front Door, Molding - Scratch - Small / (L) Front Fender, Molding - Scratch - Small / Front Bumper, Grille, Lamps - Scratch - Small / Bonnet, Headlight - Scratch - Minimal / Roof - Scratch - Minimal</p>

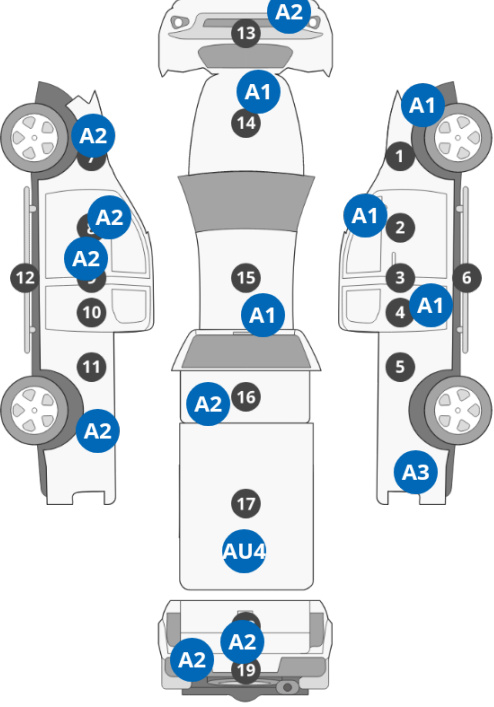
<p>Inspector Notes</p>
<p>with warranty booklet, no jack and tools, no spare tire, with LTO plate, scratches on tail light</p>
