General Information

Make	Toyota	Model	Vios
YOM	2024	Odo Meter Reading	4,000
Registration No.	EAJ3140	Chassis No.	PA1B18F35R4257848
CC	1.3	Transmission	CVT
Fuel Type	Gas	Type of Body	Sedan
Colour	Blue

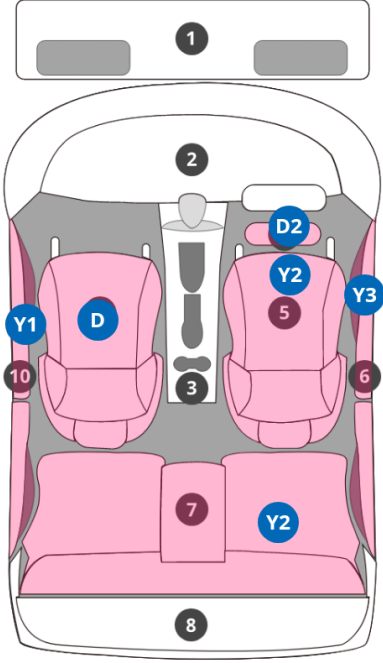
<p>a : Cut, Fray d : Loose, Deformed k : Animal Hair s : Smell t : Cigarette Burns x : Defective y : Stain</p>

<p>A : Scratch AU : Scratch & Dent B : Modified C : Corrosion G : Stone chip P : Faded S : Rust SC : Rust & Corrosion U : Dent X : Defective Y : Crack, Gap</p>
<p>Remarks (L) Front Floor Mat - Worked - Small / (L) Front Seat - Worn - Yes / (R) Front Seat - Grime - Small / Rear Seat - Grime - Small / (R) Front Trim - Grime - Medium / (L) Front Trim - Grime - Minimal</p>	<p>Remarks (R) Front Door, Molding - Scratch - Minimal / (R) Rear Door, Molding - Scratch - Minimal / Trunk Hood, Rear Gate - Scratch - Minimal / Front Bumper, Grille, Lamps - Scratch - Small / Bonnet, Headlight - Scratch - Minimal / (L) Front Door, Molding - Scratch - Minimal / Roof - Scratch - Minimal / (L) Rear Fender, Molding - Scratch - Minimal / (L) Mirror - Scratch - Minimal / (R) Mirror - Scratch, Peeled - Minimal / (R) Front Fender, Molding - Scratch - Minimal / (R) Rear Fender, Molding - Scratch - Minimal / Rear Bumper, Lamps, Panels - Scratch - Minimal / (L) Rear Door, Molding - Dent - Small</p>
