## General Information

| Make | Toyota | Model | Innova |
| Registration No. | NGK3958 | Chassis No. | PA2JA8EM0L0083560 |

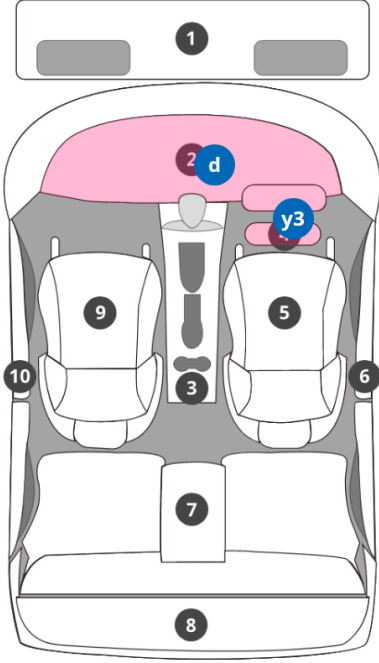
| <b>Remarks</b><br>(L) Front Floor Mat - Grime - Medium / Dashboard - Traces of Adhesive Tape - Yes | <b>Remarks</b><br>(L) Rear Fender - Repair Traces - Yes / (R) Front Fender, Molding - Scratch & Dent - Medium / (L) Rear Fender, Molding - Scratch & Dent - Large / Rear Bumper, Lamps, Panels - Scratch & Dent - Medium / Trunk Hood, Rear Gate - Scratch - Small / (L) Front Fender, Molding - Scratch - Minimal / Front Bumper, Grille, Lamps - Scratch - Medium / Roof - Dent - Small / (L) Front Door, Molding - Scratch - Minimal / (R) Rear Fender, Molding - Scratch - Minimal / (R) Step, In-panel, Side Spoiler - Dent - Minimal / Bonnet, Headlight - Scratch - Minimal |
