General Information

Make	Toyota	Model	Vios
YOM	2024	Odo Meter Reading	22,278
Registration No.	NFB9176	Chassis No.	PA1B18F32P4234315
CC	1.3	Transmission	CVT
Fuel Type	Gas	Type of Body	Sedan
Colour	Silver

Body / Panel Condition

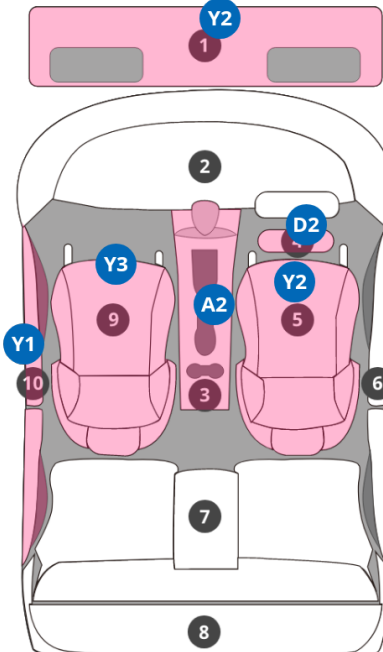
Interior Evaluation : B	Exterior Evaluation : C

<p>a : Cut, Fray d : Loose, Deformed k : Animal Hair s : Smell t : Cigarette Burns x : Defective y : Stain</p>

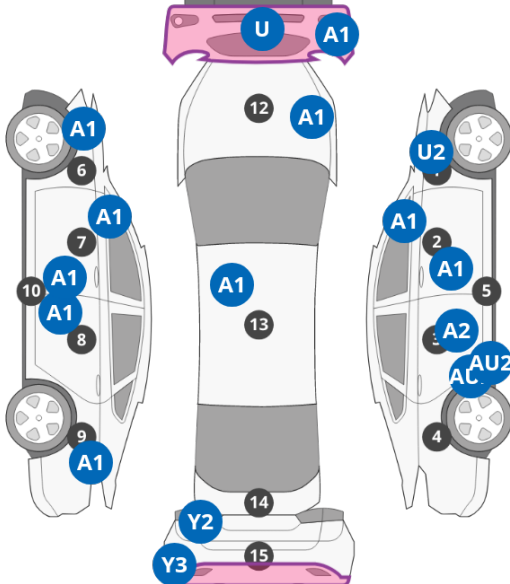
<p>A : Scratch AU : Scratch & Dent B : Modified C : Corrosion G : Stone chip P : Faded S : Rust SC : Rust & Corrosion U : Dent X : Defective Y : Crack, Gap</p>
<p>Remarks (L) Front Seat - Grime - Medium / (R) Front Seat - Grime - Small / (L) Front Floor Mat - Worked - Small / (L) Front Trim - Grime - Minimal / Ceiling - Grime - Small / Console, Switchs, Vents - Worn, Scratch, Cut, Crack - Small</p>	<p>Remarks (R) Mirror - Scratch - Minimal / (R) Front Fender, Molding - Dent - Small / (R) Rear Fender, Molding - Scratch & Dent - Small / (R) Rear Door, Molding - Scratch - Small / (R) Front Door, Molding - Scratch - Minimal / (R) Step, In-panel, Side Spoiler - Scratch & Dent - Small / Rear Bumper, Lamps, Panels - Repair mark - Yes / Rear Bumper, Lamps, Panels - Crack, Gap - Medium / (L) Rear Fender, Molding - Scratch - Minimal / (L) Rear Door, Molding - Scratch - Minimal / (L) Front Door, Molding - Scratch - Minimal / (L) Mirror - Scratch - Minimal / (L) Front Fender, Molding - Scratch - Minimal / Member (Bolted) - Dent - Yes / Front Bumper, Grille, Lamps - Repair mark - Yes / Front Bumper, Grille, Lamps - Scratch - Minimal / Bonnet, Headlight - Scratch - Minimal / Roof - Scratch - Minimal / Trunk Hood, Rear Gate - Crack, Gap - Small</p>

<p>Inspector Notes</p>
<p>no warranty booklet, with jack and tools, with spare tire, with LTO plate, scratches on tail light</p>
