General Information

Make	Toyota	Model	Vios
YOM	2024	Odo Meter Reading	10,755
Registration No.	NFR4098	Chassis No.	PA1B18F36R4251895
CC	1.3	Transmission	CVT
Fuel Type	Gas	Type of Body	Sedan
Colour	Red

Body / Panel Condition

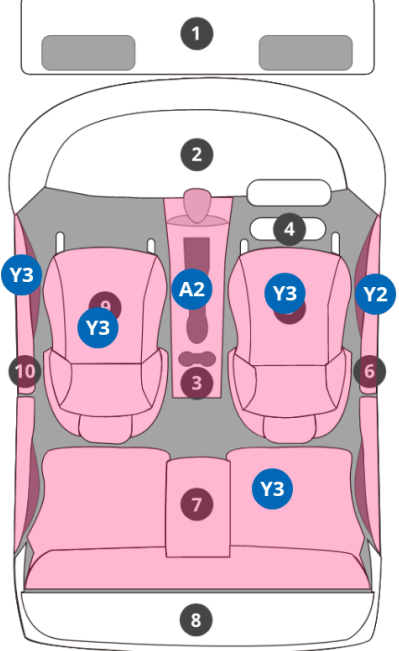
<p>a : Cut, Fray d : Loose, Deformed k : Animal Hair s : Smell t : Cigarette Burns x : Defective y : Stain</p>

<p>A : Scratch AU : Scratch & Dent B : Modified C : Corrosion G : Stone chip P : Faded S : Rust SC : Rust & Corrosion U : Dent X : Defective Y : Crack, Gap</p>
<p>Remarks Rear Seat - Grime - Medium / (R) Front Trim - Grime - Small / (R) Front Seat - Grime - Medium / (L) Front Trim - Grime - Medium / (L) Front Seat - Grime - Medium / Console, Switches, Vents - Worn, Scratch, Cut, Crack - Small</p>	<p>Remarks Trunk Hood, Rear Gate - Dent - Small / Rear Bumper, Lamps, Panels - Scratch - Small / Front Bumper, Grille, Lamps - Scratch - Large / Bonnet, Headlight - Scratch - Small / (L) Front Fender, Molding - Scratch - Minimal / (R) Front Fender, Molding - Scratch - Minimal / (R) Rear Door, Molding - Scratch - Small / Roof - Scratch - Minimal</p>
