General Information

Make	Toyota	Model	Vios
YOM	2024	Odo Meter Reading	21,010
Registration No.	NGC9683	Chassis No.	PA1B18F38R4240669
CC	1.3	Transmission	CVT
Fuel Type	Gas	Type of Body	Sedan
Colour	Red Mica Metallic

Body / Panel Condition

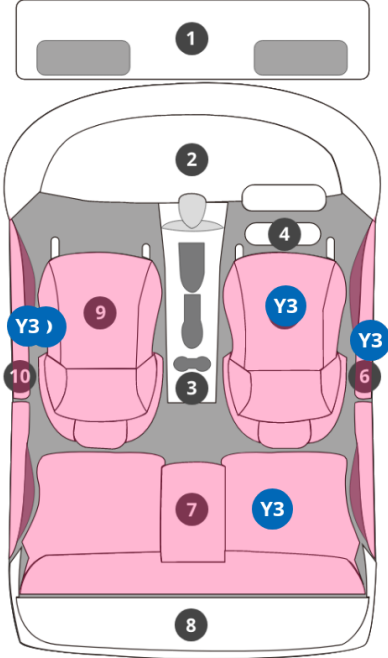
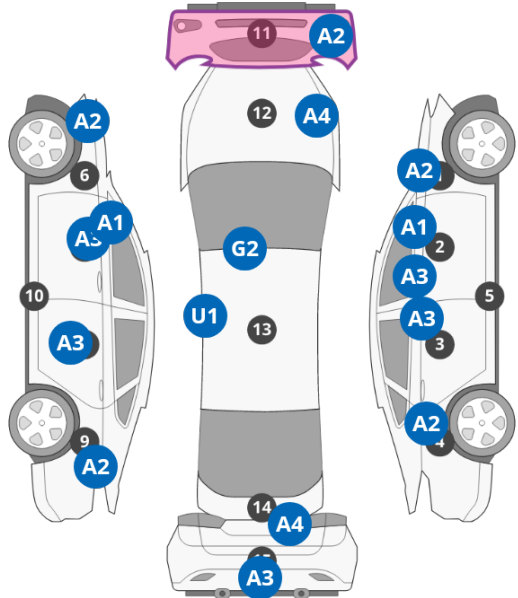
Interior Evaluation :	C	Exterior Evaluation :	E

<p>a : Cut, Fray d : Loose, Deformed k : Animal Hair s : Smell t : Cigarette Burns x : Defective y : Stain</p>		<p>A : Scratch AU : Scratch & Dent B : Modified C : Corrosion G : Stone chip P : Faded S : Rust SC : Rust & Corrosion U : Dent X : Defective Y : Crack, Gap</p>	
<p>Remarks (L) Front Seat - Worn - Yes / (R) Front Seat - Grime - Medium / Rear Seat - Grime - Medium / (R) Front Trim - Grime - Medium / (L) Front Trim - Grime - Medium</p>		<p>Remarks (L) Rear Fender - Repair Traces - Yes / Front Windshield - Scratch, Stone chip - Small / (R) Front Fender, Molding - Scratch - Small / (R) Mirror - Scratch - Minimal / (R) Front Door, Molding - Scratch - Medium / (R) Rear Door, Molding - Scratch - Medium / (R) Rear Fender, Molding - Scratch - Small / Trunk Hood, Rear Gate - Scratch - Large / Rear Bumper, Lamps, Panels - Scratch - Medium / (L) Rear Fender, Molding - Scratch - Small / (L) Rear Door, Molding - Scratch - Medium / (L) Front Door, Molding - Scratch - Medium / (L) Mirror - Scratch - Minimal / (L) Front Fender, Molding - Scratch - Small / Front Bumper, Grille, Lamps - Repair mark - Yes / Front Bumper, Grille, Lamps - Scratch - Small / Bonnet, Headlight - Scratch - Large / Roof - Dent - Minimal</p>

Inspector Notes
no warranty booklet, with jack and tools, no spare tire, with LTO plate, scratches on tail light, fog lamps issue
