## General Information

<b>Make</b>	Toyota	<b>Model</b>	Vios
<b>YOM</b>	2023	<b>Odo Meter Reading</b>	24,550
<b>Registration No.</b>	NIJ7246	<b>Chassis No.</b>	PA1B18F32P4205428
<b>CC</b>	1.3	<b>Transmission</b>	CVT
<b>Fuel Type</b>	Gas	<b>Type of Body</b>	Sedan
<b>Colour</b>	Red

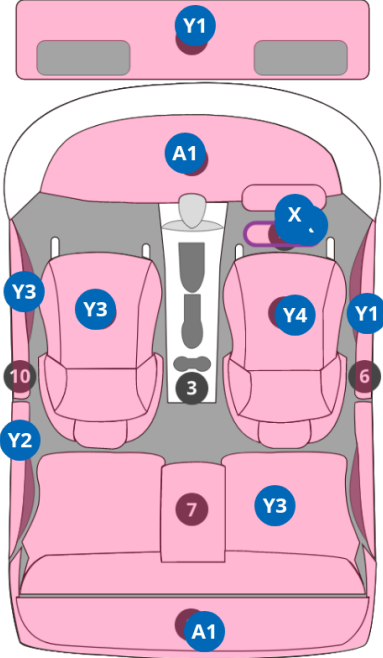
<b>Interior Evaluation :</b> <span style="float: right; color: red; font-weight: bold;">C</span>	<b>Exterior Evaluation :</b> <span style="float: right; color: red; font-weight: bold;">D</span>

<p><b>a</b> : Cut, Fray <b>d</b> : Loose, Deformed <b>k</b> : Animal Hair <b>s</b> : Smell <b>t</b> : Cigarette Burns <b>x</b> : Defective <b>y</b> : Stain</p>

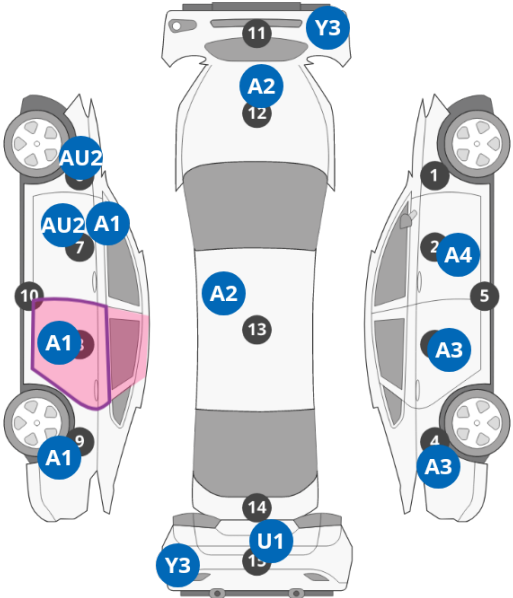
<p><b>A</b> : Scratch <b>AU</b> : Scratch &amp; Dent <b>B</b> : Modified <b>C</b> : Corrosion <b>G</b> : Stone chip <b>P</b> : Faded <b>S</b> : Rust <b>SC</b> : Rust &amp; Corrosion <b>U</b> : Dent <b>X</b> : Defective <b>Y</b> : Crack, Gap</p>
<p><b>Remarks</b> Trunk Room - Worn, Scratch, Cut, Crack - Minimal / Rear Seat - Grime - Medium / (R) Front Trim - Grime - Minimal / (R) Front Seat - Grime - Large / (L) Rear Trim - Grime - Small / (L) Front Trim - Grime - Medium / (L) Front Seat - Grime - Medium / (L) Front Floor Mat - Missing - Yes / (R) Front Floor Mat - Missing - Yes / Mat Other - Missing - Yes / Dashboard - Worn, Scratch, Cut, Crack - Minimal / Ceiling - Grime - Minimal</p>	<p><b>Remarks</b> (R) Front Door - Repair Traces - Yes / (R) Front Fender - Repair Traces - Yes / Bonnet - Repair Traces - Yes / (L) Front Fender - Repair Traces - Yes / (L) Front Door - Repair Traces - Yes / (L) Rear Door - Repair Traces - Yes / (L) Rear Fender - Repair Traces - Yes / Trunk Hood, Rear Gate - Repair Traces - Yes / (R) Rear Fender - Repair Traces - Yes / (R) Rear Door - Repair Traces - Yes / Roof - Repair Traces - Yes / Roof - Scratch - Small / (R) Front Door, Molding - Scratch - Large / (R) Rear Fender, Molding - Scratch - Medium / (R) Rear Door, Molding - Scratch - Medium / Trunk Hood, Rear Gate - Dent - Minimal / Rear Bumper, Lamps, Panels - Crack, Gap - Medium / (L) Rear Fender, Molding - Scratch - Minimal / (L) Rear Door, Molding - Repair mark - Yes / (L) Rear Door, Molding - Scratch - Minimal / (L) Front Fender, Molding - Scratch &amp; Dent - Small / (L) Front Door, Molding - Scratch &amp; Dent - Small / (L) Mirror - Scratch - Minimal / Bonnet, Headlight - Scratch - Small / Front Bumper, Grille, Lamps - Crack, Gap - Medium</p>
