General Information

Make	Toyota	Model	Vios
YOM	2024	Odo Meter Reading	6,739
Registration No.	NIP5861	Chassis No.	PA1B18F30P4226634
CC	1.3	Transmission	CVT
Fuel Type	Gas	Type of Body	Sedan
Colour	Blue

Body / Panel Condition

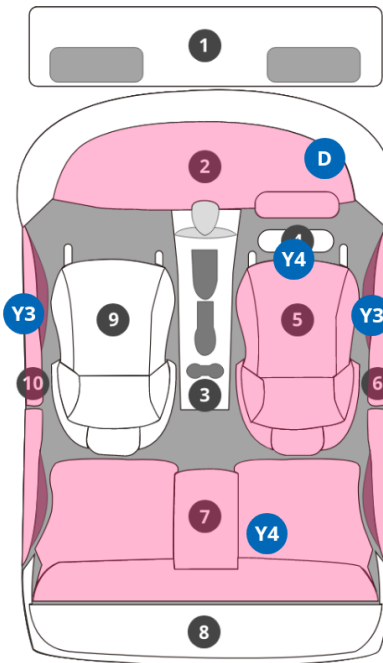
Interior Evaluation : C	Exterior Evaluation : E

<p>a : Cut, Fray d : Loose, Deformed k : Animal Hair s : Smell t : Cigarette Burns x : Defective y : Stain</p>

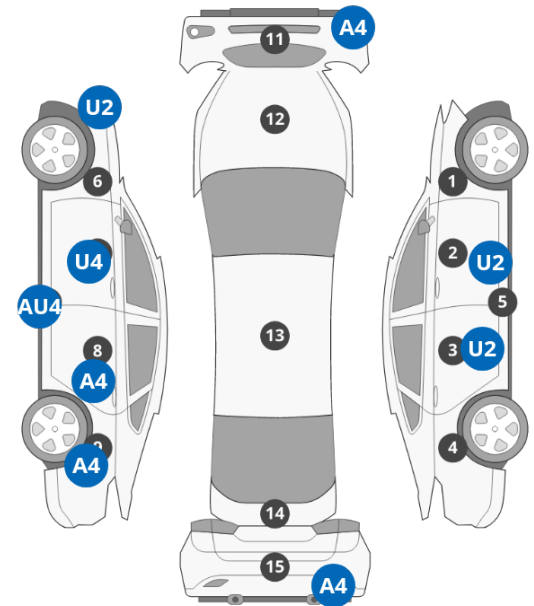
<p>A : Scratch AU : Scratch & Dent B : Modified C : Corrosion G : Stone chip P : Faded S : Rust SC : Rust & Corrosion U : Dent X : Defective Y : Crack, Gap</p>
<p>Remarks Rear Seat - Grime - Large / (R) Front Seat - Grime - Large / (R) Front Trim - Grime - Medium / (L) Front Trim - Grime - Medium / Dashboard - Traces of Adhesive Tape - Yes</p>	<p>Remarks Front Bumper, Grille, Lamps - Scratch - Large / (R) Rear Door, Molding - Dent - Small / Rear Bumper, Lamps, Panels - Scratch - Large / (R) Front Door, Molding - Dent - Small / (L) Step, In-panel, Side Spoiler - Scratch & Dent - Large / (L) Rear Fender, Molding - Scratch - Large / (L) Rear Door, Molding - Scratch - Large / (L) Front Door, Molding - Dent - Large / (L) Front Fender, Molding - Dent - Small</p>
