General Information

Make	Toyota	Model	Vios
YOM	2025	Odo Meter Reading	15,880
Registration No.	NJA2072	Chassis No.	PA1B18F34R4280800
CC	1.3	Transmission	CVT
Fuel Type	Gas	Type of Body	Sedan
Colour	Silver

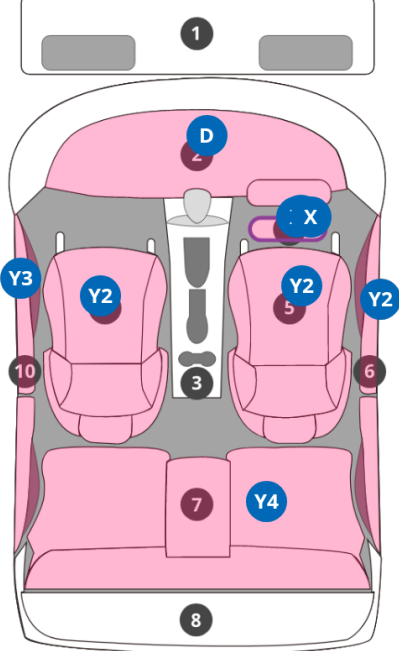
Interior Evaluation : C	Exterior Evaluation : B

<p>a : Cut, Fray d : Loose, Deformed k : Animal Hair s : Smell t : Cigarette Burns x : Defective y : Stain</p>

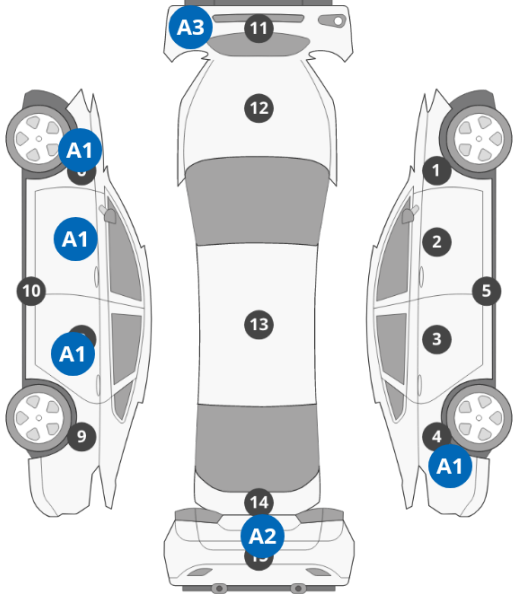
<p>A : Scratch AU : Scratch & Dent B : Modified C : Corrosion G : Stone chip P : Faded S : Rust SC : Rust & Corrosion U : Dent X : Defective Y : Crack, Gap</p>
<p>Remarks Rear Seat - Grime - Large / (R) Front Trim - Grime - Small / (R) Front Seat - Grime - Small / (L) Front Trim - Grime - Medium / (L) Front Seat - Grime - Small / (R) Front Floor Mat - Missing - Yes / (L) Front Floor Mat - Missing - Yes / Mat Other - Missing - Yes / Dashboard - Traces of Adhesive Tape - Yes</p>	<p>Remarks (R) Front Fender - Repair Traces - Yes / (L) Front Fender, Molding - Scratch - Minimal / (L) Front Door, Molding - Scratch - Minimal / Front Bumper, Grille, Lamps - Scratch - Medium / (L) Rear Door, Molding - Scratch - Minimal / Trunk Hood, Rear Gate - Scratch - Small / (R) Rear Fender, Molding - Scratch - Minimal</p>
