General Information

Make	Toyota	Model	Wigo
YOM	2025	Odo Meter Reading	3,247
Registration No.	NKK3206	Chassis No.	MHKAA1BCRJ026043
CC	1.0	Transmission	CVT
Fuel Type	Gas	Type of Body	Hatchback
Colour	Gray

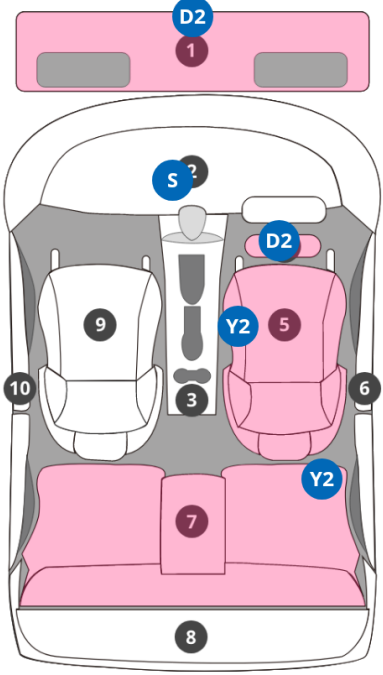
Interior Evaluation : B	Exterior Evaluation : D

<p>a : Cut, Fray d : Loose, Deformed k : Animal Hair s : Smell t : Cigarette Burns x : Defective y : Stain</p>

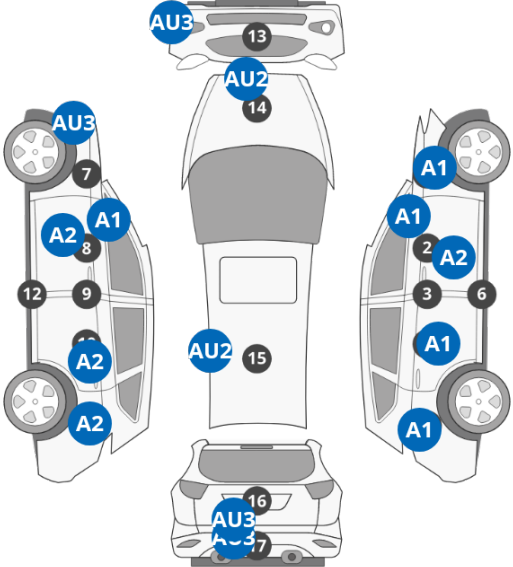
<p>A : Scratch AU : Scratch & Dent B : Modified C : Corrosion G : Stone chip P : Faded S : Rust SC : Rust & Corrosion U : Dent X : Defective Y : Crack, Gap</p>
<p>Remarks Overall Interior - Smell - Yes / (L) Front Floor Mat - Worked - Small / (R) Front Seat - Grime - Small / Rear Seat - Grime - Small / Ceiling - Crinkle - Small</p>	<p>Remarks (R) Mirror - Scratch - Minimal / (R) Front Fender, Molding - Scratch - Minimal / (R) Front Door, Molding - Scratch - Small / (R) Rear Door, Molding - Scratch - Minimal / (R) Rear Fender, Molding - Scratch - Minimal / Rear Bumper, Lamps, Panels - Scratch & Dent - Medium / Trunk Hood, Rear Gate - Scratch & Dent - Medium / (L) Rear Fender, Molding - Scratch - Small / (L) Rear Door, Molding - Scratch - Small / (L) Front Door, Molding - Scratch - Small / (L) Mirror - Scratch - Minimal / (L) Front Fender, Molding - Scratch & Dent - Medium / Front Bumper, Grille, Lamps - Scratch & Dent - Medium / Bonnet, Headlight - Scratch & Dent - Small / Roof - Scratch & Dent - Small</p>
