General Information

Make	Toyota	Model	Corolla Altis
YOM	2010	Odo Meter Reading	97,425
Registration No.	NWQ304	Chassis No.	MR053ZEE106159252
CC	1.6	Transmission	M/T
Fuel Type	Gas	Type of Body	Sedan
Colour	Silver

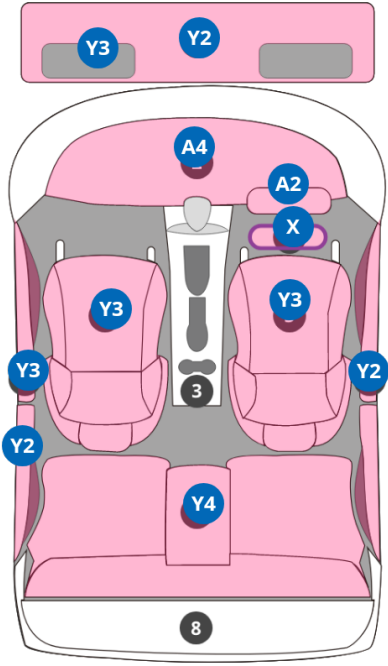
Interior Evaluation : D	Exterior Evaluation : E

<p>a : Cut, Fray d : Loose, Deformed k : Animal Hair s : Smell t : Cigarette Burns x : Defective y : Stain</p>

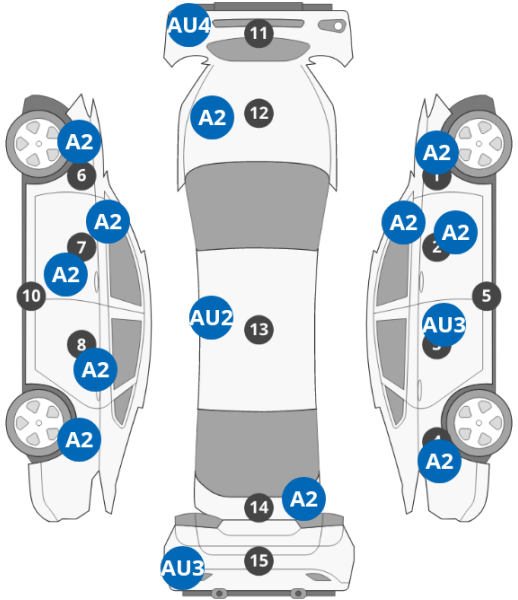
<p>A : Scratch AU : Scratch & Dent B : Modified C : Corrosion G : Stone chip P : Faded S : Rust SC : Rust & Corrosion U : Dent X : Defective Y : Crack, Gap</p>
<p>Remarks Ceiling - Grime - Small / Mat Other - Missing - Yes / Sunvisor, Sunglass Holder - Grime - Medium / (R) Front Trim - Grime - Small / Overall Interior - Worn as per age - Yes / (R) Front Seat - Grime - Medium / Rear Seat - Grime - Large / (L) Rear Trim - Grime - Small / (L) Front Trim - Grime - Medium / (L) Front Seat - Grime - Medium / Steering Wheel - Worn, Peel, Crack - Small / Dashboard - Worn, Scratch, Cut, Crack - Large</p>	<p>Remarks Front Bumper, Grille, Lamps - Scratch & Dent - Large / (R) Front Fender, Molding - Scratch - Small / (R) Mirror - Scratch - Small / (R) Front Door, Molding - Scratch - Small / (R) Rear Door, Molding - Scratch & Dent - Medium / (R) Rear Fender, Molding - Scratch - Small / Rear Bumper, Lamps, Panels - Scratch & Dent - Medium / (L) Rear Fender, Molding - Scratch - Small / (L) Rear Door, Molding - Scratch - Small / (L) Front Door, Molding - Scratch - Small / (L) Front Fender, Molding - Scratch - Small / (L) Mirror - Scratch - Small / Roof - Scratch & Dent - Small / Bonnet, Headlight - Scratch - Small / Trunk Hood, Rear Gate - Scratch - Small</p>
