General Information

Make	Toyota	Model	Avanza
YOM	2025	Odo Meter Reading	30,661
Registration No.	CCG4162	Chassis No.	MHFAA1BY2R0029527
CC	1.3	Transmission	CVT
Fuel Type	Gas	Type of Body	MPV
Colour	Black

Body / Panel Condition

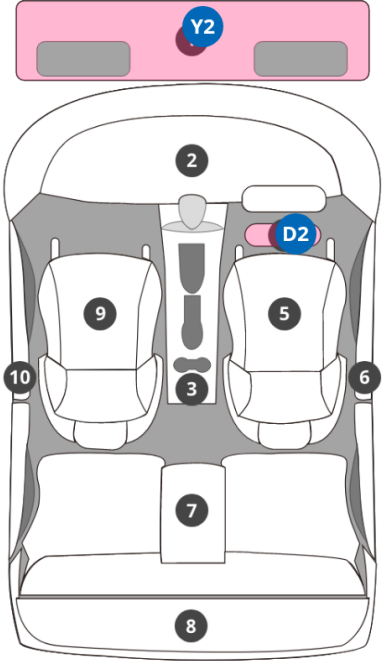
Interior Evaluation : A	Exterior Evaluation : B

<p>a : Cut, Fray d : Loose, Deformed k : Animal Hair s : Smell t : Cigarette Burns x : Defective y : Stain</p>

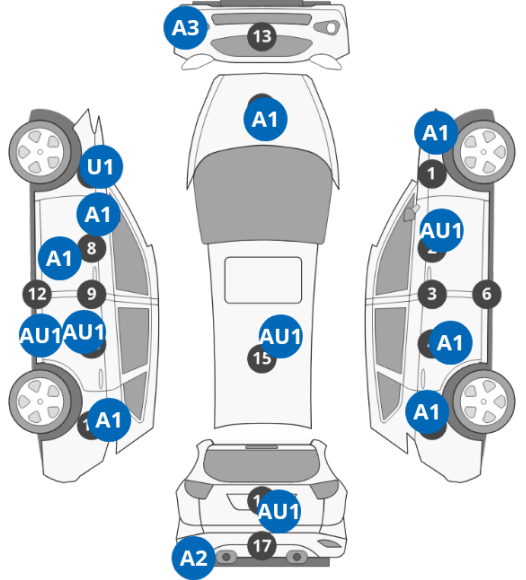
<p>A : Scratch AU : Scratch & Dent B : Modified C : Corrosion G : Stone chip P : Faded S : Rust SC : Rust & Corrosion U : Dent X : Defective Y : Crack, Gap</p>
<p>Remarks Ceiling - Grime - Small / (L) Front Floor Mat - Worked - Small</p>	<p>Remarks Front Bumper, Grille, Lamps - Scratch - Medium / (L) Front Fender, Molding - Dent - Minimal / (L) Mirror - Scratch - Minimal / (L) Front Door, Molding - Scratch - Minimal / (L) Rear Door, Molding - Scratch & Dent - Minimal / (L) Step, In-panel, Side Spoiler - Scratch & Dent - Minimal / Bonnet, Headlight - Scratch - Minimal / Roof - Scratch & Dent - Minimal / (R) Front Fender, Molding - Scratch - Minimal / (R) Front Door, Molding - Scratch & Dent - Minimal / (R) Rear Door, Molding - Scratch - Minimal / (R) Rear Fender, Molding - Scratch - Minimal / (L) Rear Fender, Molding - Scratch - Minimal / Trunk Hood, Rear Gate - Scratch & Dent - Minimal / Rear Bumper, Lamps, Panels - Scratch - Small</p>

<p>Inspector Notes</p>
<p>With LTO plate and Sparetire, No Tools and Jack and Warranty booklet, scratch headlight and tail light.</p>
