General Information

Make	Toyota	Model	Vios
YOM	2025	Odo Meter Reading	9,556
Registration No.	BAG8059	Chassis No.	PA1B18F37R4278863
CC	1.3	Transmission	CVT
Fuel Type	Gas	Type of Body	Sedan
Colour	Silver

Body / Panel Condition

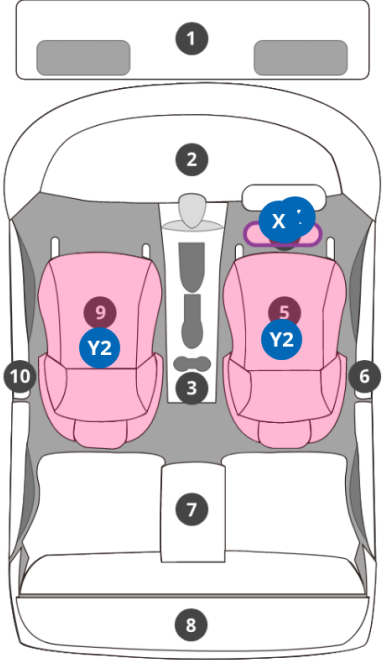
Interior Evaluation : B	Exterior Evaluation : B

<p>a : Cut, Fray d : Loose, Deformed k : Animal Hair s : Smell t : Cigarette Burns x : Defective y : Stain</p>

<p>A : Scratch AU : Scratch & Dent B : Modified C : Corrosion G : Stone chip P : Faded S : Rust SC : Rust & Corrosion U : Dent X : Defective Y : Crack, Gap</p>
<p>Remarks (L) Front Floor Mat - Missing - Yes / (R) Front Floor Mat - Missing - Yes / Mat Other - Missing - Yes / (R) Front Seat - Grime - Small / (L) Front Seat - Grime - Small</p>	<p>Remarks (L) Front Door, Molding - Scratch - Small / (L) Rear Door, Molding - Scratch - Small / Rear Bumper, Lamps, Panels - Scratch - Small / Bonnet, Headlight - Scratch - Small / (R) Front Fender, Molding - Scratch - Minimal / (R) Mirror - Scratch - Minimal / (L) Mirror - Scratch - Minimal / Roof - Scratch - Minimal / (R) Front Door, Molding - Scratch - Minimal / (R) Rear Door, Molding - Scratch & Dent - Minimal</p>
