General Information

Make	Ford	Model	Everest
YOM	2012	Odo Meter Reading	125,956
Registration No.	UIZ578	Chassis No.	MNCUS4D10CW402156
CC	2.2	Transmission	A/T
Fuel Type	Diesel	Type of Body	Wagon
Colour	White

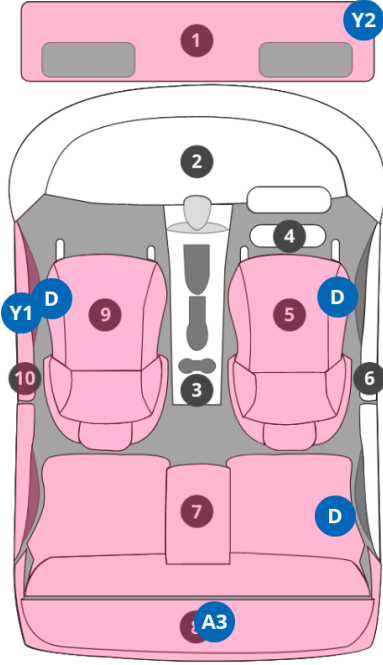
<p>a : Cut, Fray d : Loose, Deformed k : Animal Hair s : Smell t : Cigarette Burns x : Defective y : Stain</p>

<p>A : Scratch AU : Scratch & Dent B : Modified C : Corrosion G : Stone chip P : Faded S : Rust SC : Rust & Corrosion U : Dent X : Defective Y : Crack, Gap</p>
<p>Remarks Overall Interior - Worn as per age - Yes / Rear Seat - Worn - Yes / (R) Front Seat - Worn - Yes / (L) Front Seat - Worn - Yes / (L) Front Trim - Grime - Minimal / Ceiling - Grime - Small / Trunk Room - Worn, Scratch, Cut, Crack - Medium</p>	<p>Remarks (R) Rear Fender - Repair Traces - Yes / (R) Mirror - Stuck - Yes / (R) Front Fender, Molding - Scratch - Small / (R) Step, In-panel, Side Spoiler - Scratch - Small / (R) Front Door, Molding - Scratch - Minimal / Overall Exterior - Faded(Color, Gloss) - Yes / Overall Exterior - Worn as per age - Yes / (R) Rear Door, Molding - Scratch - Minimal / (R) Rear Fender, Molding - Scratch - Minimal / Rear Bumper, Lamps, Panels - Scratch - Medium / Trunk Hood, Rear Gate - Scratch - Medium / (L) Rear Fender, Molding - Scratch - Small / (L) Rear Door, Molding - Scratch - Medium / (L) Front Door, Molding - Scratch - Small / (R) Mirror - Scratch - Minimal / (L) Mirror - Scratch - Minimal / (L) Front Fender, Molding - Scratch - Minimal / Front Bumper, Grille, Lamps - Scratch - Medium / Bonnet, Headlight - Scratch & Dent - Medium / Roof - Rust, Corrosion - Small / Front Windshield - Scratch, Stone chip - Small</p>
