General Information

Make	Toyota	Model	Innova
YOM	2017	Odo Meter Reading	67,826
Registration No.	NBY1272	Chassis No.	PA2GA8EM4H0023119
CC	2.8	Transmission	M/T
Fuel Type	Diesel	Type of Body	Wagon
Colour	Red Mica Metallic

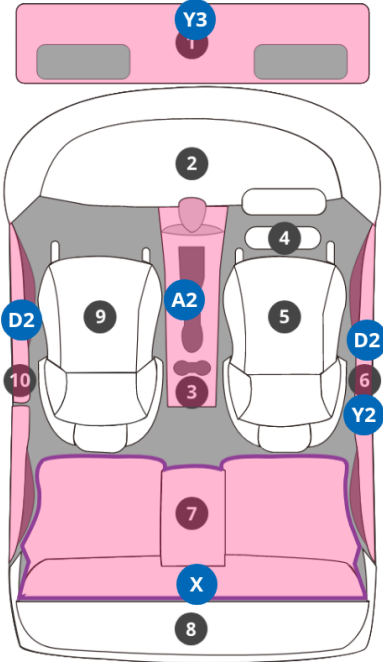
Interior Evaluation : C	Exterior Evaluation : E

<p>a : Cut, Fray d : Loose, Deformed k : Animal Hair s : Smell t : Cigarette Burns x : Defective y : Stain</p>

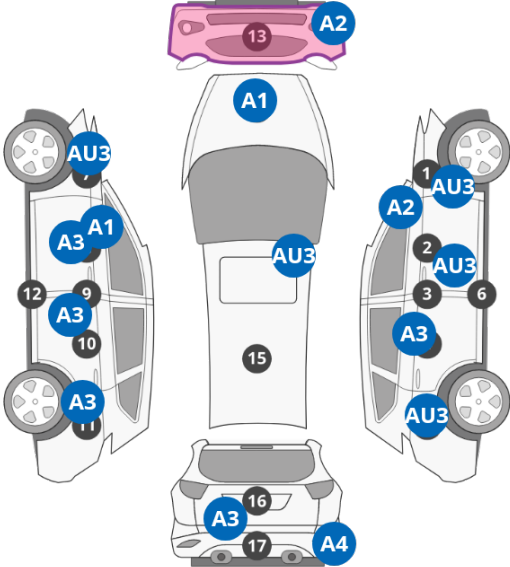
<p>A : Scratch AU : Scratch & Dent B : Modified C : Corrosion G : Stone chip P : Faded S : Rust SC : Rust & Corrosion U : Dent X : Defective Y : Crack, Gap</p>
<p>Remarks Overall Interior - Worn as per age - Yes / Rear Seat Head Rest - Missing - Yes / (L) Front Trim - Worked - Small / (R) Front Trim - Worked - Small / Knobs - Worn, Peel, Crack - Small / Ceiling - Grime - Medium / (R) Rear Trim - Grime - Small</p>	<p>Remarks (R) Front Fender - Repair Traces - Yes / (L) Rear Door - Repair Traces - Yes / (L) Rear Fender - Repair Traces - Yes / (R) Rear Fender - Repair Traces - Yes / (R) Rear Door - Repair Traces - Yes / Roof - Repair Traces - Yes / (R) Mirror - Scratch - Small / (R) Front Fender, Molding - Scratch & Dent - Medium / (R) Front Door, Molding - Scratch & Dent - Medium / (R) Rear Door, Molding - Scratch - Medium / (R) Rear Fender, Molding - Scratch & Dent - Medium / Rear Bumper, Lamps, Panels - Scratch - Large / Trunk Hood, Rear Gate - Scratch - Medium / (L) Rear Fender, Molding - Scratch - Medium / (L) Rear Door, Molding - Scratch - Medium / (L) Front Door, Molding - Scratch - Medium / (L) Mirror - Scratch - Minimal / (L) Front Fender, Molding - Scratch & Dent - Medium / Front Bumper, Grille, Lamps - Repair mark - Yes / Front Bumper, Grille, Lamps - Scratch - Small / Bonnet, Headlight - Scratch - Minimal / Roof - Scratch & Dent - Medium</p>
