General Information

Make	Toyota	Model	Vios
YOM	2023	Odo Meter Reading	36,117
Registration No.	NIJ6171	Chassis No.	PA1B18F31P4205257
CC	1.3	Transmission	CVT
Fuel Type	Gas	Type of Body	Sedan
Colour	Black

Body / Panel Condition

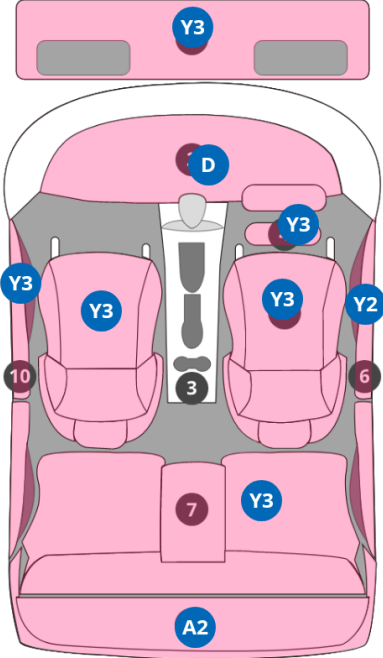
Interior Evaluation : C	Exterior Evaluation : D

<p>a : Cut, Fray d : Loose, Deformed k : Animal Hair s : Smell t : Cigarette Burns x : Defective y : Stain</p>

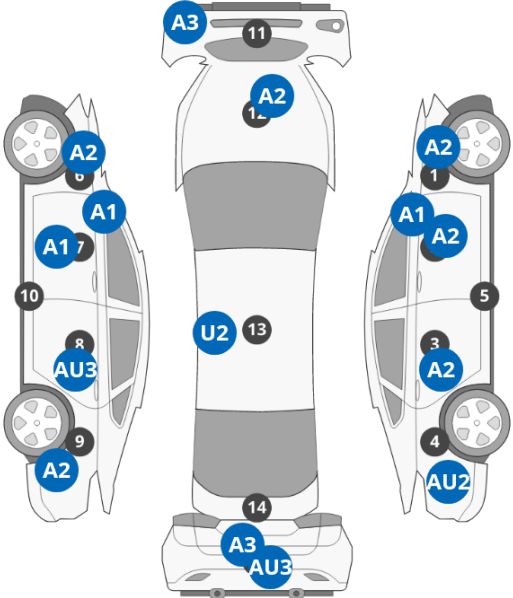
<p>A : Scratch AU : Scratch & Dent B : Modified C : Corrosion G : Stone chip P : Faded S : Rust SC : Rust & Corrosion U : Dent X : Defective Y : Crack, Gap</p>
<p>Remarks (R) Front Seat - Grime - Medium / (R) Front Trim - Grime - Small / Rear Seat - Grime - Medium / Trunk Room - Worn, Scratch, Cut, Crack - Small / (L) Front Trim - Grime - Medium / (L) Front Seat - Grime - Medium / (L) Front Floor Mat - Grime - Medium / Dashboard - Traces of Adhesive Tape - Yes / Ceiling - Grime - Medium</p>	<p>Remarks (L) Rear Fender, Molding - Scratch - Small / (L) Front Door, Molding - Scratch - Minimal / (L) Front Fender, Molding - Scratch - Small / Front Bumper, Grille, Lamps - Scratch - Medium / (L) Rear Door, Molding - Scratch & Dent - Medium / Bonnet, Headlight - Scratch - Small / (R) Front Fender, Molding - Scratch - Small / (R) Front Door, Molding - Scratch - Small / (R) Rear Door, Molding - Scratch - Small / (R) Rear Fender, Molding - Scratch & Dent - Small / Trunk Hood, Rear Gate - Scratch - Medium / Rear Bumper, Lamps, Panels - Scratch & Dent - Medium / Roof - Dent - Small / (L) Mirror - Scratch - Minimal / (R) Mirror - Scratch - Minimal</p>
