General Information

Body / Panel Condition

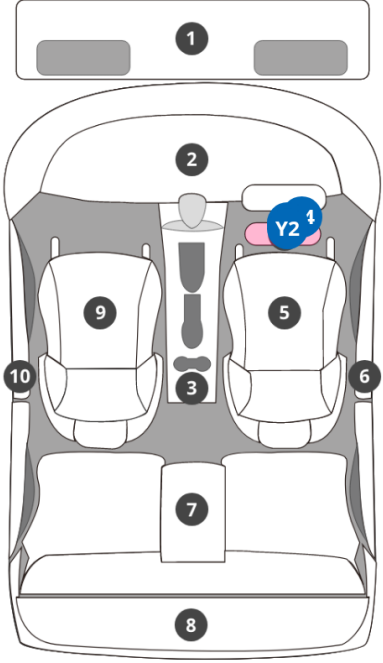
Interior Evaluation : C	Exterior Evaluation : B

<p>a : Cut, Fray d : Loose, Deformed k : Animal Hair s : Smell t : Cigarette Burns x : Defective y : Stain</p>

<p>A : Scratch AU : Scratch & Dent B : Modified C : Corrosion G : Stone chip P : Faded S : Rust SC : Rust & Corrosion U : Dent X : Defective Y : Crack, Gap</p>
<p>Remarks (L) Front Floor Mat - Worked - Large / (R) Front Floor Mat - Grime - Small / Mat Other - Grime - Small</p>	<p>Remarks Front Bumper, Grille, Lamps - Scratch - Medium / (L) Front Fender, Molding - Scratch - Minimal / (L) Front Door, Molding - Scratch & Dent - Minimal / (L) Rear Door, Molding - Scratch - Small / Member (Bolted) - Dent - Yes / Bonnet, Headlight - Scratch - Small / (R) Front Door, Molding - Scratch - Small / (R) Rear Door, Molding - Scratch - Minimal / (R) Rear Fender, Molding - Scratch - Minimal / Trunk Hood, Rear Gate - Scratch - Minimal / Rear Bumper, Lamps, Panels - Scratch - Minimal / (L) Rear Fender, Molding - Scratch - Minimal / Roof - Scratch - Small / (R) Mirror - Scratch - Minimal</p>

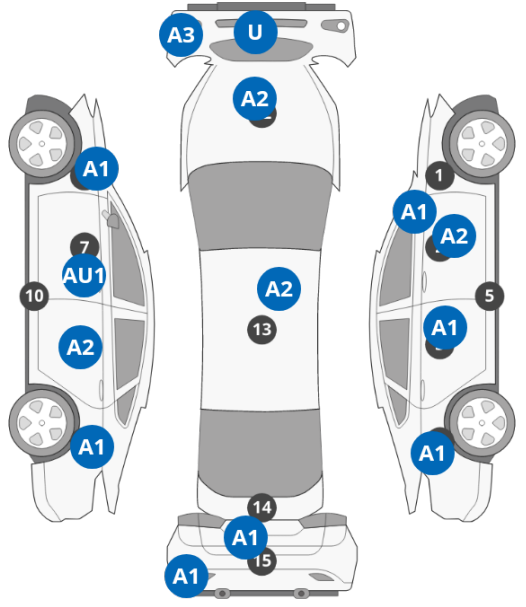
<p>Inspector Notes</p>
<p>With LTO plate and Sparetire and Jack and Incomplete Tools and warranty booklet, scratch headlight and tail light, Worn Tires, foul smell.</p>
