General Information

Make	Toyota	Model	Innova
YOM	2024	Odo Meter Reading	50,023
Registration No.	NFR1103	Chassis No.	PA2JA8EM2R0137885
CC	2.8	Transmission	A/T
Fuel Type	Diesel	Type of Body	Wagon
Colour	Silver

Body / Panel Condition

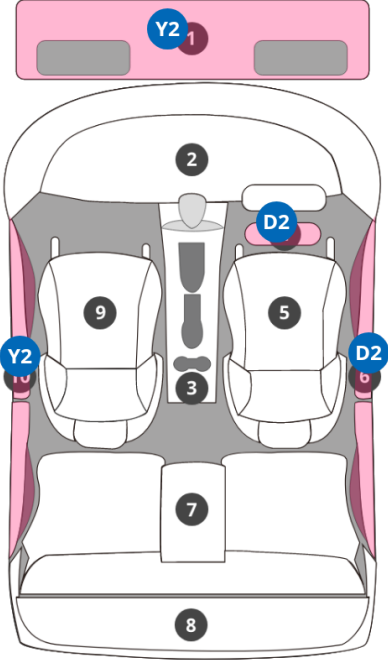
Interior Evaluation : A	Exterior Evaluation : C

<p>A : Scratch AU : Scratch & Dent B : Modified C : Corrosion G : Stone chip P : Faded S : Rust SC : Rust & Corrosion U : Dent X : Defective Y : Crack, Gap</p>
<p>Remarks Ceiling - Grime - Small / (L) Front Trim - Grime - Small / (R) Front Trim - Worked - Small / (L) Front Floor Mat - Worked - Small</p>	<p>Remarks Member (Bolted) - Dent - Yes / Front Bumper, Grille, Lamps - Scratch & Dent - Medium / (L) Front Door, Molding - Scratch & Dent - Minimal / (L) Rear Door, Molding - Scratch - Minimal / (L) Rear Fender, Molding - Scratch & Dent - Large / Rear Bumper, Lamps, Panels - Scratch - Medium / (R) Rear Door, Molding - Scratch & Dent - Medium / (R) Rear Fender, Molding - Scratch & Dent - Small / (R) Front Door, Molding - Scratch & Dent - Small / Bonnet, Headlight - Scratch - Small / (L) Front Fender, Molding - Scratch - Minimal / (R) Front Fender, Molding - Scratch - Small / (R) Center Panel - Scratch & Dent - Minimal</p>
