General Information

Make	Ford	Model	Explorer
YOM	2014	Odo Meter Reading	88,732
Registration No.	AAL4722	Chassis No.	1FM5J7F90EGB05341
CC	2.0	Transmission	A/T
Fuel Type	Gas	Type of Body	Wagon
Colour	White

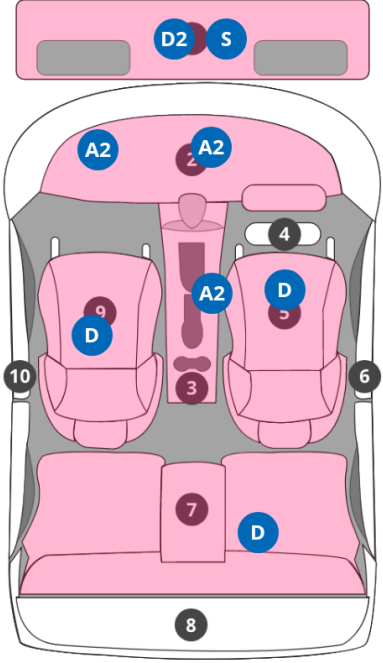
Interior Evaluation : C	Exterior Evaluation : C

<p>a : Cut, Fray d : Loose, Deformed k : Animal Hair s : Smell t : Cigarette Burns x : Defective y : Stain</p>

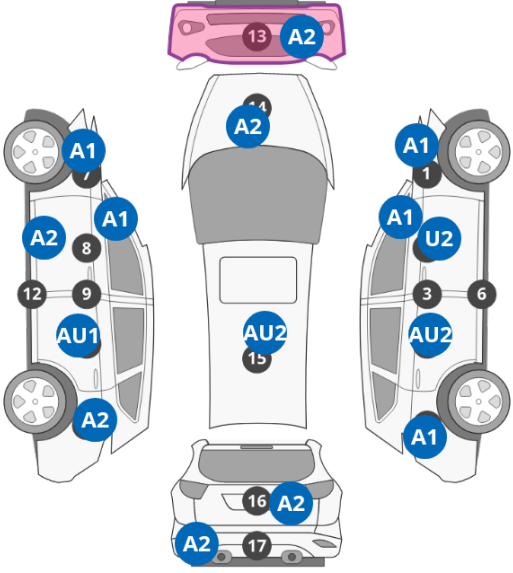
<p>A : Scratch AU : Scratch & Dent B : Modified C : Corrosion G : Stone chip P : Faded S : Rust SC : Rust & Corrosion U : Dent X : Defective Y : Crack, Gap</p>
<p>Remarks Overall Interior - Worn as per age - Yes / Overall Interior - Smell - Yes / (L) Front Seat - Worn - Yes / (R) Front Seat - Worn - Yes / Rear Seat - Worn - Yes / Steering Wheel - Worn, Peel, Crack - Small / Dashboard - Worn, Scratch, Cut, Crack - Small / Console, Switches, Vents - Worn, Scratch, Cut, Crack - Small / Ceiling - Loose, Deformed - Small</p>	<p>Remarks Trunk Hood, Rear Gate - Repair Traces - Yes / (R) Rear Door - Repair Traces - Yes / (L) Mirror - Scratch - Minimal / (L) Rear Door, Molding - Scratch & Dent - Minimal / (L) Front Door, Molding - Scratch - Small / (L) Rear Fender, Molding - Scratch - Small / Trunk Hood, Rear Gate - Scratch - Small / Rear Bumper, Lamps, Panels - Scratch - Small / (R) Rear Fender, Molding - Scratch - Minimal / (R) Front Door, Molding - Dent - Small / (R) Rear Door, Molding - Scratch & Dent - Small / (R) Front Fender, Molding - Scratch - Minimal / (L) Front Fender, Molding - Scratch - Minimal / Front Bumper, Grille, Lamps - Repair mark - Yes / Front Bumper, Grille, Lamps - Scratch - Small / (R) Mirror - Scratch - Minimal / Roof - Scratch & Dent - Small / Bonnet, Headlight - Scratch - Small</p>
