General Information

Make	Chevrolet	Model	Trax
YOM	2019	Odo Meter Reading	42,098
Registration No.	NEB1203	Chassis No.	KLBA7684GB737500
CC	1.3	Transmission	A/T
Fuel Type	Gas	Type of Body	SUV
Colour	Blue

Body / Panel Condition

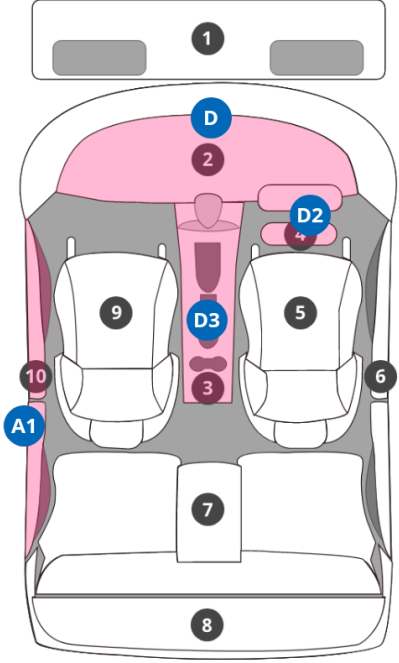
Interior Evaluation : B	Exterior Evaluation : B

<p>A : Scratch AU : Scratch & Dent B : Modified C : Corrosion G : Stone chip P : Faded S : Rust SC : Rust & Corrosion U : Dent X : Defective Y : Crack, Gap</p>
<p>Remarks Dashboard - Traces of Adhesive Tape - Yes / Console, Switches, Vents - Loose, Deformed - Medium / (L) Front Floor Mat - Loose, Deformed - Small / (L) Rear Trim - Cut, Crack - Minimal</p>	<p>Remarks (R) Rear Door, Molding - Scratch & Dent - Minimal / Rear Bumper, Lamps, Panels - Scratch & Dent - Small / Trunk Hood, Rear Gate - Scratch & Dent - Small / (L) Rear Fender, Molding - Scratch - Small / (L) Rear Door, Molding - Scratch - Minimal / (L) Front Door, Molding - Scratch & Dent - Small / Front Bumper, Grille, Lamps - Scratch - Minimal / Bonnet, Headlight - Scratch - Small / Roof - Scratch - Medium / (R) Mirror - Scratch, Peeled - Minimal</p>
