General Information

Make	Toyota	Model	Vios
YOM	2024	Odo Meter Reading	43,536
Registration No.	NFR7549	Chassis No.	PA1B18F33R4250722
CC	1.3	Transmission	CVT
Fuel Type	Gas	Type of Body	Sedan
Colour	Silver

Body / Panel Condition

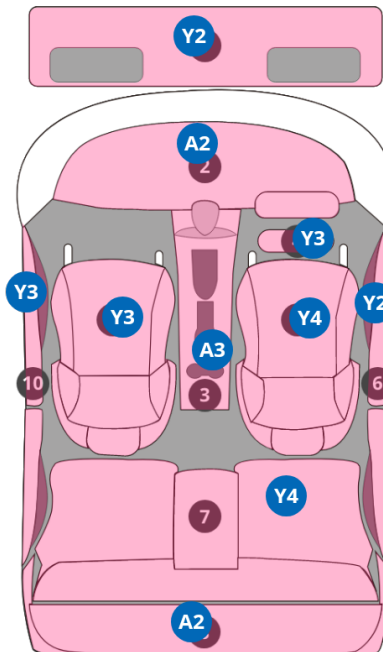
Interior Evaluation : D	Exterior Evaluation : D

<p>a : Cut, Fray d : Loose, Deformed k : Animal Hair s : Smell t : Cigarette Burns x : Defective y : Stain</p>

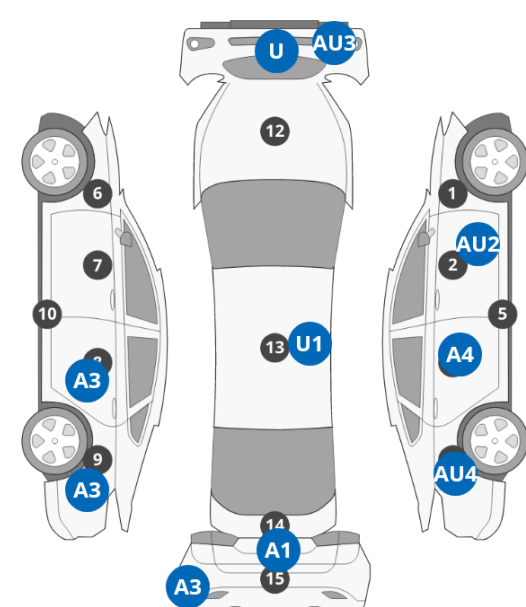
<p>A : Scratch AU : Scratch & Dent B : Modified C : Corrosion G : Stone chip P : Faded S : Rust SC : Rust & Corrosion U : Dent X : Defective Y : Crack, Gap</p>
Remarks Rear Seat - Grime - Large / (R) Front Trim - Grime - Small / (R) Front Seat - Grime - Large / Trunk Room - Worn, Scratch, Cut, Crack - Small / (L) Front Trim - Grime - Medium / (L) Front Seat - Grime - Medium / Console, Switches, Vents - Worn, Scratch, Cut, Crack - Medium / (L) Front Floor Mat - Grime - Medium / Ceiling - Grime - Small / Dashboard - Worn, Scratch, Cut, Crack - Small	Remarks Bonnet - Repair Traces - Yes / Trunk Hood, Rear Gate - Scratch - Minimal / Rear Bumper, Lamps, Panels - Scratch - Medium / (L) Rear Fender, Molding - Scratch - Medium / (L) Rear Door, Molding - Scratch - Medium / Front Bumper, Grille, Lamps - Scratch & Dent - Medium / (R) Front Door, Molding - Scratch & Dent - Small / (R) Rear Door, Molding - Scratch - Large / (R) Rear Fender, Molding - Scratch & Dent - Large / Roof - Dent - Minimal / Member (Bolted) - Dent - Yes
