General Information

Make	Toyota	Model	Innova
YOM	2020	Odo Meter Reading	97,656
Registration No.	NGL1695	Chassis No.	PA2JA8EM4L0050456
CC	2.8	Transmission	A/T
Fuel Type	Diesel	Type of Body	Wagon
Colour	Black

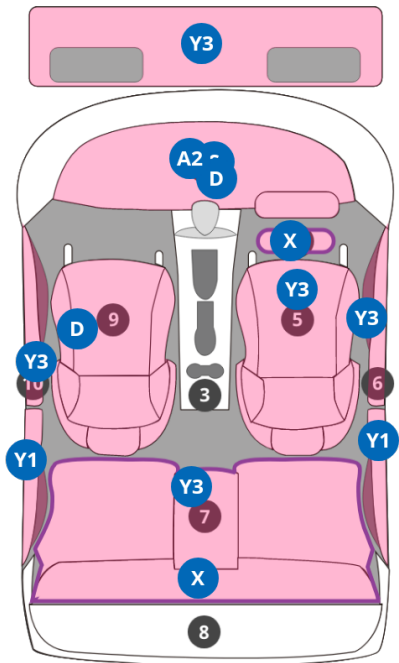
Interior Evaluation : C	Exterior Evaluation : E

<p>a : Cut, Fray d : Loose, Deformed k : Animal Hair s : Smell t : Cigarette Burns x : Defective y : Stain</p>

<p>A : Scratch AU : Scratch & Dent B : Modified C : Corrosion G : Stone chip P : Faded S : Rust SC : Rust & Corrosion U : Dent X : Defective Y : Crack, Gap</p>
<p>Remarks Overall Interior - Worn as per age - Yes / Overall Interior - Smell - Yes / (R) Front Seat - Grime - Medium / (L) Front Seat - Worn - Yes / Rear Seat Head Rest - Missing - Yes / Rear Seat - Grime - Medium / Mat Other - Missing - Yes / (R) Rear Trim - Grime - Minimal / (L) Rear Trim - Grime - Minimal / (R) Front Trim - Grime - Medium / (L) Front Trim - Grime - Medium / Dashboard - Traces of Adhesive Tape - Yes / Dashboard - Worn, Scratch, Cut, Crack - Small / Ceiling - Grime - Medium</p>	<p>Remarks (R) Front Fender - Repair Traces - Yes / Bonnet - Repair Traces - Yes / Member (Bolted) - Dent - Yes / (R) Mirror - Crack - Cracks / (R) Mirror - Scratch - Medium / (R) Front Fender, Molding - Scratch - Small / (R) Front Door, Molding - Scratch & Dent - Large / (R) Rear Door, Molding - Scratch & Dent - Large / (R) Step, In-panel, Side Spoiler - Scratch & Dent - Medium / (R) Rear Fender, Molding - Scratch & Dent - Large / Rear Bumper, Lamps, Panels - Repair mark - Yes / Rear Bumper, Lamps, Panels - Scratch & Dent - Large / Trunk Hood, Rear Gate - Scratch & Dent - Medium / (L) Rear Fender, Molding - Scratch & Dent - Large / (L) Rear Door, Molding - Scratch & Dent - Medium / (L) Mirror - Scratch - Small / (L) Front Door, Molding - Scratch - Small / Front Bumper, Grille, Lamps - Crack, Gap - Large / (L) Front Fender, Molding - Scratch & Dent - Medium / Bonnet, Headlight - Scratch - Small / Roof - Dent - Large</p>
