General Information

Make	Toyota	Model	Raize
YOM	2023	Odo Meter Reading	80,037
Registration No.	EAG2644	Chassis No.	MHKAB1BA9NJ037596
CC	1.2	Transmission	CVT
Fuel Type	Gas	Type of Body	SUV
Colour	Gray

Body / Panel Condition

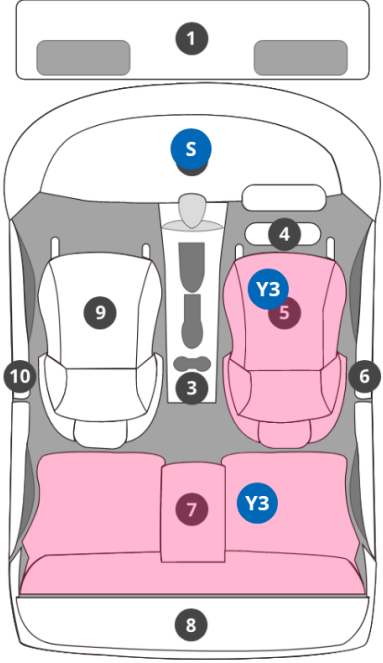
Interior Evaluation : C	Exterior Evaluation : E

<p>a : Cut, Fray d : Loose, Deformed k : Animal Hair s : Smell t : Cigarette Burns x : Defective y : Stain</p>

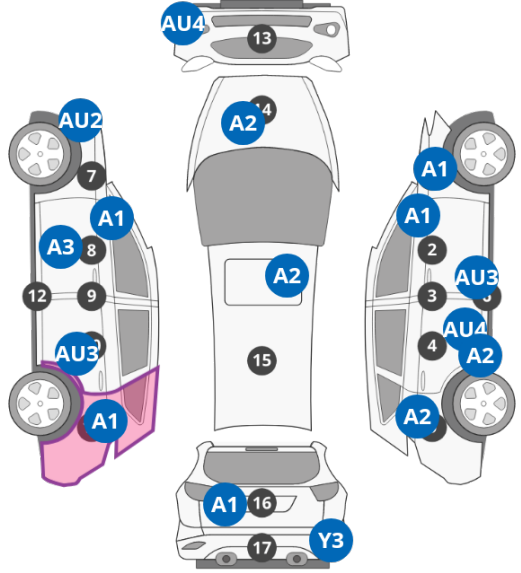
<p>A : Scratch AU : Scratch & Dent B : Modified C : Corrosion G : Stone chip P : Faded S : Rust SC : Rust & Corrosion U : Dent X : Defective Y : Crack, Gap</p>
<p>Remarks Overall Interior - Smell - Yes / (R) Front Seat - Grime - Medium / Rear Seat - Grime - Medium / Overall Interior - Worn as per age - Yes</p>	<p>Remarks (L) Rear Fender, Molding - Partially Missing - Yes / (R) Front Fender, Molding - Scratch - Minimal / (R) Rear Door, Molding - Scratch & Dent - Large / (R) Front Door, Molding - Scratch & Dent - Medium / (R) Step, In-panel, Side Spoiler - Scratch - Small / (R) Mirror - Scratch - Minimal / (R) Rear Fender, Molding - Scratch - Small / Rear Bumper, Lamps, Panels - Crack, Gap - Medium / Trunk Hood, Rear Gate - Scratch - Minimal / (L) Rear Fender, Molding - Scratch - Minimal / (L) Rear Door, Molding - Scratch & Dent - Medium / (L) Front Door, Molding - Scratch - Medium / (L) Mirror - Scratch - Minimal / Front Bumper, Grille, Lamps - Scratch & Dent - Large / (L) Front Fender, Molding - Scratch & Dent - Small / Bonnet, Headlight - Scratch - Small / Roof - Scratch - Small</p>
