General Information

Make	Toyota	Model	Vios
YOM	2025	Odo Meter Reading	24,214
Registration No.	NHS8606	Chassis No.	PA1B18F33R4267097
CC	1.3	Transmission	CVT
Fuel Type	Gas	Type of Body	Sedan
Colour	Blue

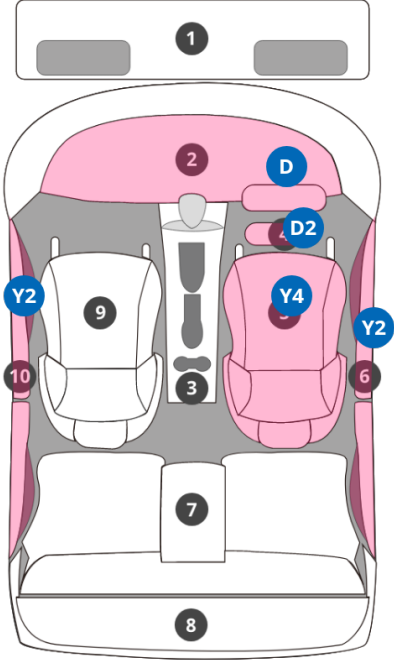
Interior Evaluation : C	Exterior Evaluation : C

<p>a : Cut, Fray d : Loose, Deformed k : Animal Hair s : Smell t : Cigarette Burns x : Defective y : Stain</p>

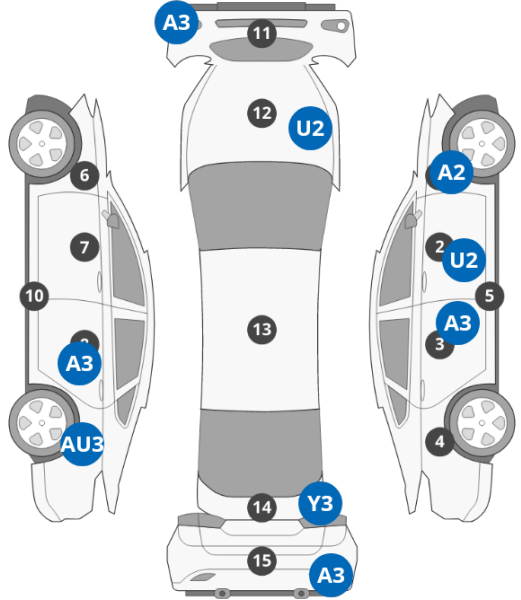
<p>A : Scratch AU : Scratch & Dent B : Modified C : Corrosion G : Stone chip P : Faded S : Rust SC : Rust & Corrosion U : Dent X : Defective Y : Crack, Gap</p>
<p>Remarks Dashboard - Traces of Adhesive Tape - Yes / (R) Front Seat - Grime - Large / (R) Front Floor Mat - Worked - Small / (R) Front Trim - Grime - Small / (L) Front Trim - Grime - Small</p>	<p>Remarks (L) Rear Fender - Repair Traces - Yes / Front Bumper, Grille, Lamps - Scratch - Medium / Bonnet, Headlight - Dent - Small / Trunk Hood, Rear Gate - Crack, Gap - Medium / Rear Bumper, Lamps, Panels - Scratch - Medium / (R) Rear Door, Molding - Scratch - Medium / (R) Front Door, Molding - Dent - Small / (R) Front Fender, Molding - Scratch - Small / (L) Rear Fender, Molding - Scratch & Dent - Medium / (L) Rear Door, Molding - Scratch - Medium</p>
