General Information

Make	Toyota	Model	Innova
YOM	2024	Odo Meter Reading	31,871
Registration No.	CCC6283	Chassis No.	PA2J8EM8P0133594
CC	2.8	Transmission	A/T
Fuel Type	Diesel	Type of Body	Wagon
Colour	Black

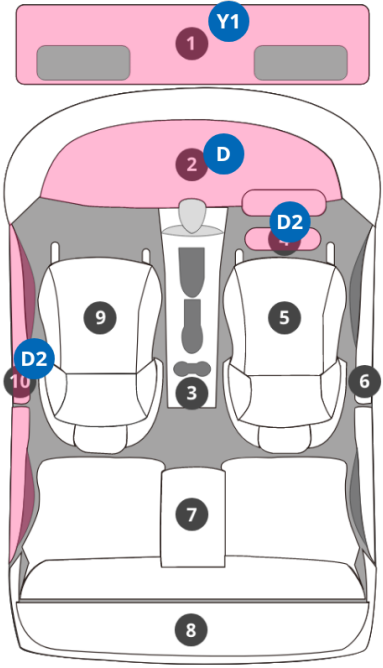
Interior Evaluation : A	Exterior Evaluation : C

<p>a : Cut, Fray d : Loose, Deformed k : Animal Hair s : Smell t : Cigarette Burns x : Defective y : Stain</p>

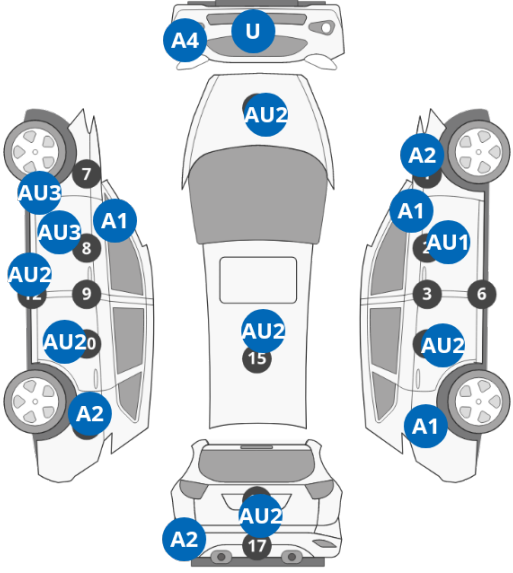
<p>A : Scratch AU : Scratch & Dent B : Modified C : Corrosion G : Stone chip P : Faded S : Rust SC : Rust & Corrosion U : Dent X : Defective Y : Crack, Gap</p>
<p>Remarks (L) Front Floor Mat - Worked - Small / (L) Front Trim - Worked - Small / Dashboard - Traces of Adhesive Tape - Yes / Ceiling - Grime - Minimal</p>	<p>Remarks Member (Bolted) - Dent - Yes / Front Bumper, Grille, Lamps - Scratch - Large / (L) Front Fender, Molding - Scratch & Dent - Medium / (L) Mirror - Scratch - Minimal / (L) Front Door, Molding - Scratch & Dent - Medium / (L) Rear Door, Molding - Scratch & Dent - Small / (L) Rear Fender, Molding - Scratch - Small / (L) Step, In-panel, Side Spoiler - Scratch & Dent - Small / Bonnet, Headlight - Scratch & Dent - Small / (R) Front Fender, Molding - Scratch - Small / (R) Mirror - Scratch - Minimal / (R) Front Door, Molding - Scratch & Dent - Minimal / (R) Rear Door, Molding - Scratch & Dent - Small / Trunk Hood, Rear Gate - Scratch & Dent - Small</p>
