General Information

Make	Toyota	Model	Vios
YOM	2024	Odo Meter Reading	30,773
Registration No.	CAZ9855	Chassis No.	PA1B18F31R424649
CC	1.3	Transmission	CVT
Fuel Type	Gas	Type of Body	Sedan
Colour	White

Body / Panel Condition

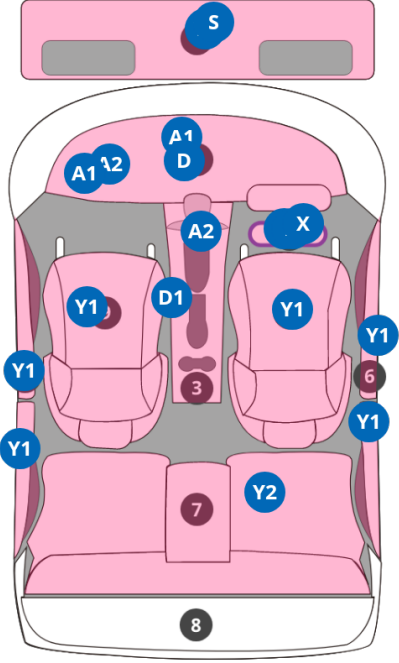
Interior Evaluation : B	Exterior Evaluation : C

<p>a : Cut, Fray d : Loose, Deformed k : Animal Hair s : Smell t : Cigarette Burns x : Defective y : Stain</p>

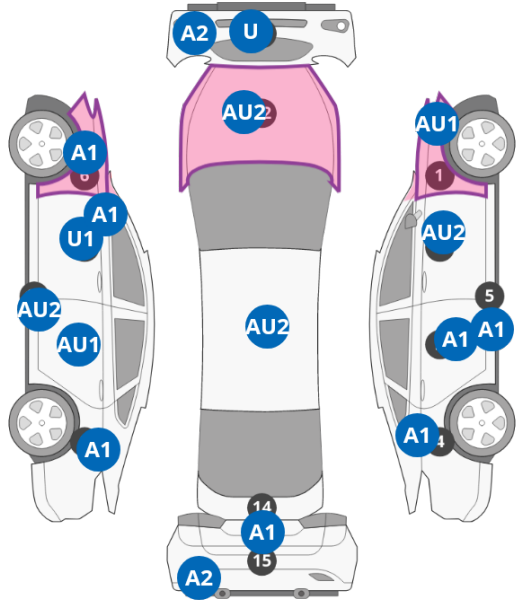
<p>A : Scratch AU : Scratch & Dent B : Modified C : Corrosion G : Stone chip P : Faded S : Rust SC : Rust & Corrosion U : Dent X : Defective Y : Crack, Gap</p>
Remarks (L) Front Floor Mat - Missing - Yes / (R) Front Floor Mat - Missing - Yes / Mat Other - Missing - Yes / Ceiling - Grime - Small / Overall Interior - Smell - Yes / (L) Front Seat - Grime - Minimal / (R) Front Seat - Grime - Minimal / (L) Front Trim - Grime - Minimal / (R) Front Trim - Grime - Minimal / (R) Rear Trim - Grime - Minimal / (L) Rear Trim - Grime - Minimal / Console, Switches, Vents - Loose, Deformed - Minimal / Knobs - Worn, Peel, Crack - Small / Dashboard - Worn, Scratch, Cut, Crack - Minimal / Dashboard - Traces of Adhesive Tape - Yes / Steering Wheel - Worn, Peel, Crack - Small / Glove Box - Worn, Scratch, Cut, Crack - Minimal / Rear Seat - Grime - Small	Remarks (R) Front Fender - Repair Traces - Yes / Bonnet - Repair Traces - Yes / (L) Front Fender - Repair Traces - Yes / (L) Front Fender, Molding - Repair mark - Yes / Bonnet, Headlight - Repair mark - Yes / (R) Front Fender, Molding - Repair mark - Yes / Member (Bolted) - Dent - Yes / (L) Front Door, Molding - Dent - Minimal / (L) Rear Door, Molding - Scratch & Dent - Minimal / (L) Rear Fender, Molding - Scratch - Minimal / (L) Step, In-panel, Side Spoiler - Scratch & Dent - Small / (L) Front Fender, Molding - Scratch - Minimal / (L) Mirror - Scratch - Minimal / Front Bumper, Grille, Lamps - Scratch - Small / (R) Front Fender, Molding - Scratch & Dent - Minimal / (R) Front Door, Molding - Scratch & Dent - Small / (R) Rear Door, Molding - Scratch - Minimal / (R) Step, In-panel, Side Spoiler - Scratch - Minimal / (R) Rear Fender, Molding - Scratch - Minimal / Trunk Hood, Rear Gate - Scratch - Minimal / Rear Bumper, Lamps, Panels - Scratch - Small / Roof - Scratch & Dent - Small / Bonnet, Headlight - Scratch & Dent - Small

Inspector Notes
With LTO plate, No warranty booklet and Sparetire and Jack and Tools, scratch and crack headlight and tail light, Worn Tires, foul smell, No spare key, Abnormal vibration on engine, plate light issue, Room light issue, headlight issue, no reverse camera.
