## General Information

| Make | Toyota | Model | Innova |

## Body / Panel Condition

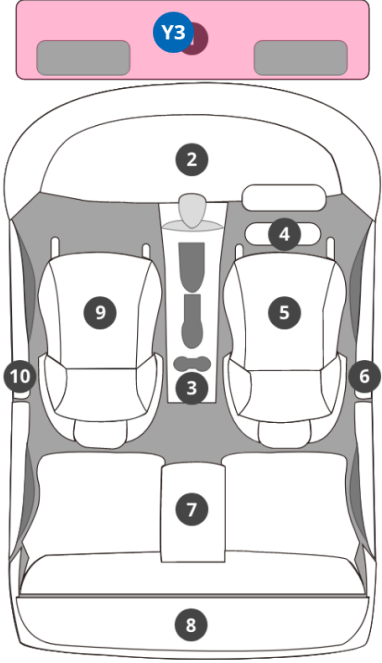
| <b>Interior Evaluation :</b> <span style="color: red; font-weight: bold;">B</span> | <b>Exterior Evaluation :</b> <span style="color: red; font-weight: bold;">B</span> |
| <b>Remarks</b><br>Ceiling - Grime - Medium | <b>Remarks</b><br>(R) Front Door - Repair Traces - Yes / (R) Front Fender - Repair Traces - Yes / Bonnet - Repair Traces - Yes / Trunk Hood, Rear Gate - Repair Traces - Yes / (R) Rear Door, Molding - Dent - Small / (R) Front Door, Molding - Dent - Small / Trunk Hood, Rear Gate - Dent - Small / (L) Rear Fender, Molding - Dent - Minimal / (L) Front Door, Molding - Dent - Minimal / Roof - Dent - Small / Front Bumper, Grille, Lamps - Scratch - Medium / Member (Bolted) - Dent - Yes / Rear Bumper, Lamps, Panels - Scratch - Small |
