General Information

Make	Toyota	Model	Vios
YOM	2024	Odo Meter Reading	4,962
Registration No.	NJF2049	Chassis No.	PA1B18F37R4260606
CC	1.3	Transmission	CVT
Fuel Type	Gas	Type of Body	Sedan
Colour	Red

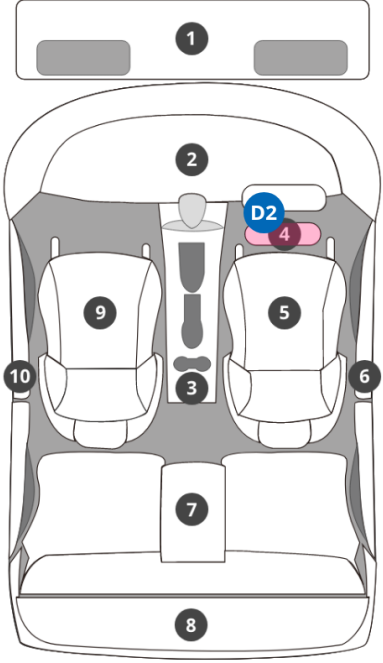
Interior Evaluation : A	Exterior Evaluation : E

<p>a : Cut, Fray d : Loose, Deformed k : Animal Hair s : Smell t : Cigarette Burns x : Defective y : Stain</p>

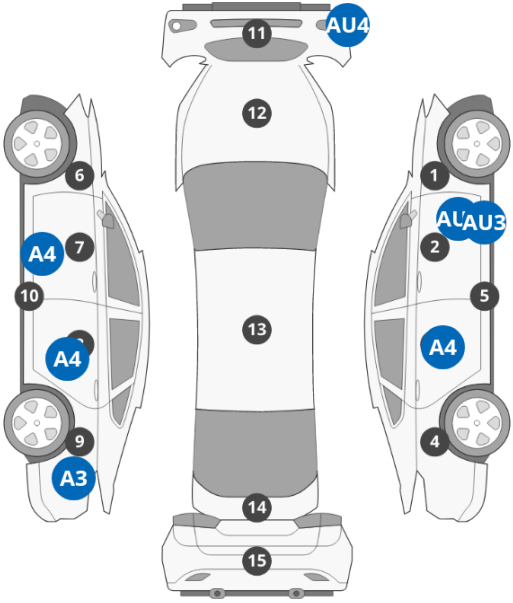
<p>A : Scratch AU : Scratch & Dent B : Modified C : Corrosion G : Stone chip P : Faded S : Rust SC : Rust & Corrosion U : Dent X : Defective Y : Crack, Gap</p>
Remarks (L) Front Floor Mat - Worked - Small	Remarks (R) Front Door, Molding - Scratch & Dent - Large / (R) Step, In-panel, Side Spoiler - Scratch & Dent - Medium / Front Bumper, Grille, Lamps - Scratch & Dent - Large / (L) Front Door, Molding - Scratch - Large / (R) Rear Door, Molding - Scratch - Large / (L) Rear Fender, Molding - Scratch - Medium / (L) Rear Door, Molding - Scratch - Large
Frame Evaluation : A	Functional Evaluation : B
Remarks Defects not found	Remarks Battery - Weak - Yes / Spare Key - Issue - Unexist
