General Information

Make	Toyota	Model	Vios
YOM	2024	Odo Meter Reading	29,362
Registration No.	NKA2953	Chassis No.	PA1B18F32R4241851
CC	1.3	Transmission	CVT
Fuel Type	Gas	Type of Body	Sedan
Colour	Black

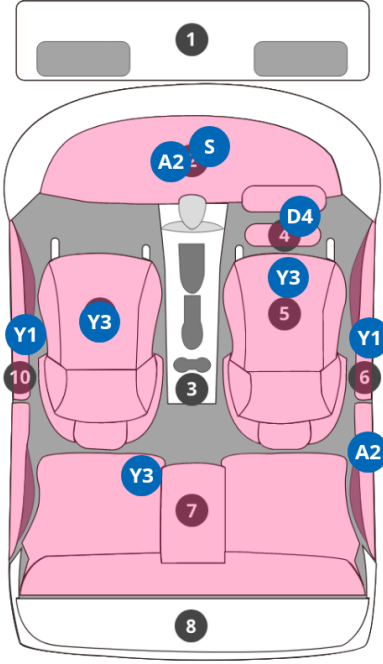
Interior Evaluation : C	Exterior Evaluation : E

<p>a : Cut, Fray d : Loose, Deformed k : Animal Hair s : Smell t : Cigarette Burns x : Defective y : Stain</p>

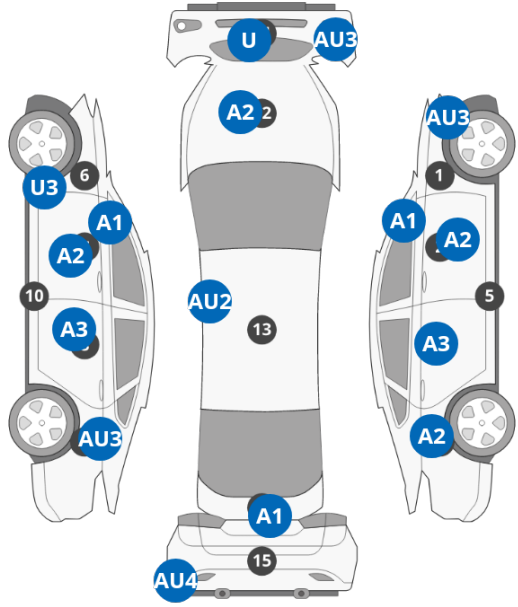
<p>A : Scratch AU : Scratch & Dent B : Modified C : Corrosion G : Stone chip P : Faded S : Rust SC : Rust & Corrosion U : Dent X : Defective Y : Crack, Gap</p>
<p>Remarks Overall Interior - Smell - Yes / (R) Front Seat - Grime - Medium / (L) Front Seat - Grime - Medium / (R) Rear Trim - Cut, Crack - Small / (R) Front Trim - Grime - Minimal / (L) Front Trim - Grime - Minimal / Rear Seat - Grime - Medium / (L) Front Floor Mat - Worked - Large / Dashboard - Worn, Scratch, Cut, Crack - Small</p>	<p>Remarks Member (Bolted) - Dent - Yes / (R) Front Fender, Molding - Scratch & Dent - Medium / (R) Mirror - Scratch - Minimal / (R) Front Door, Molding - Scratch - Small / (R) Rear Door, Molding - Scratch - Medium / (R) Rear Fender, Molding - Scratch - Small / Rear Bumper, Lamps, Panels - Scratch & Dent - Large / Trunk Hood, Rear Gate - Scratch - Minimal / (L) Rear Fender, Molding - Scratch & Dent - Medium / (L) Rear Door, Molding - Scratch - Medium / (L) Front Door, Molding - Scratch - Small / (L) Mirror - Scratch - Minimal / (L) Front Fender, Molding - Dent - Medium / Front Bumper, Grille, Lamps - Scratch & Dent - Medium / Bonnet, Headlight - Scratch - Small / Roof - Scratch & Dent - Small</p>
