## General Information

<b>Make</b>	Toyota	<b>Model</b>	Vios
<b>YOM</b>	2024	<b>Odo Meter Reading</b>	26,084
<b>Registration No.</b>	DBM9485	<b>Chassis No.</b>	PA1B18F37R4246365
<b>CC</b>	1.3	<b>Transmission</b>	CVT
<b>Fuel Type</b>	Gas	<b>Type of Body</b>	Sedan
<b>Colour</b>	Red Mica Metallic

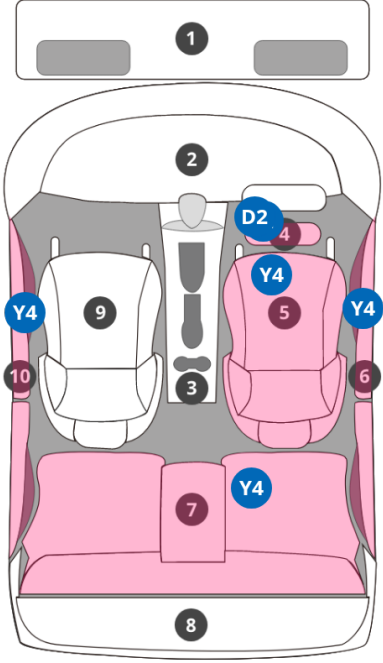
<b>Interior Evaluation :</b> <span style="float: right; color: red; font-weight: bold;">C</span>	<b>Exterior Evaluation :</b> <span style="float: right; color: red; font-weight: bold;">E</span>

<p><b>a</b> : Cut, Fray <b>d</b> : Loose, Deformed <b>k</b> : Animal Hair <b>s</b> : Smell <b>t</b> : Cigarette Burns <b>x</b> : Defective <b>y</b> : Stain</p>

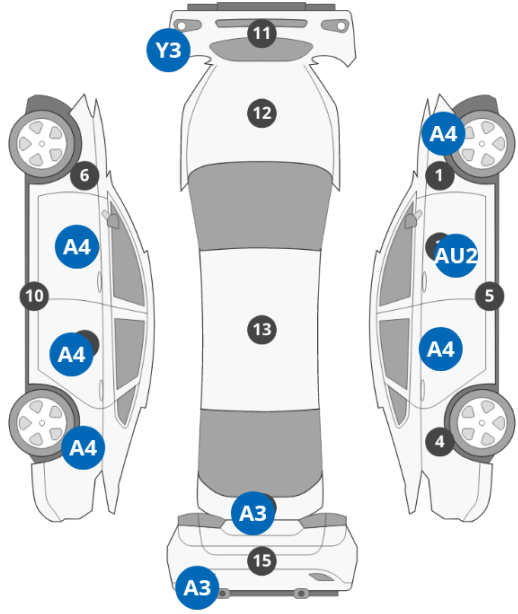
<p><b>A</b> : Scratch <b>AU</b> : Scratch &amp; Dent <b>B</b> : Modified <b>C</b> : Corrosion <b>G</b> : Stone chip <b>P</b> : Faded <b>S</b> : Rust <b>SC</b> : Rust &amp; Corrosion <b>U</b> : Dent <b>X</b> : Defective <b>Y</b> : Crack, Gap</p>
<p><b>Remarks</b> Rear Seat - Grime - Large / (R) Front Seat - Grime - Large / (R) Front Trim - Grime - Large / (L) Front Trim - Grime - Large / Carpet - Worked - Minimal / (L) Front Floor Mat - Worked - Small</p>	<p><b>Remarks</b> (L) Front Door, Molding - Scratch - Large / (L) Rear Door, Molding - Scratch - Large / (L) Rear Fender, Molding - Scratch - Large / Trunk Hood, Rear Gate - Scratch - Medium / Rear Bumper, Lamps, Panels - Scratch - Medium / (R) Rear Door, Molding - Scratch - Large / (R) Front Door, Molding - Scratch &amp; Dent - Small / (R) Front Fender, Molding - Scratch - Large / Front Bumper, Grille, Lamps - Crack, Gap - Medium</p>
