General Information

Make	Toyota	Model	Hilux
YOM	2025	Odo Meter Reading	15,136
Registration No.	DBQ5047	Chassis No.	MR0JB8DD3R3553393
CC	2.4	Transmission	M/T
Fuel Type	Diesel	Type of Body	Pickup
Colour	White

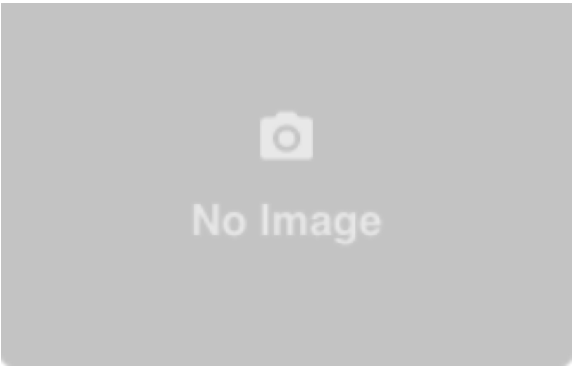
Interior Evaluation : C	Exterior Evaluation : E
<div style="text-align: center; background-color: #cccccc; padding: 50px;">

<p>No Image</p> </div> <p>a : Cut, Fray d : Loose, Deformed k : Animal Hair s : Smell t : Cigarette Burns x : Defective y : Stain</p>

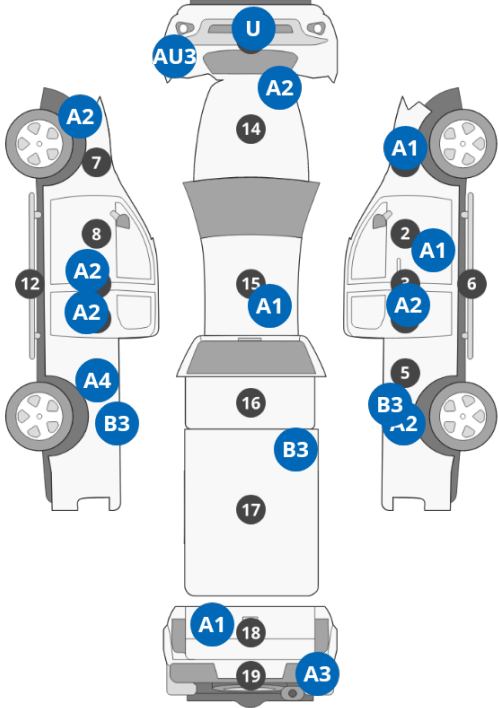
<p>A : Scratch AU : Scratch & Dent B : Modified C : Corrosion G : Stone chip P : Faded S : Rust SC : Rust & Corrosion U : Dent X : Defective Y : Crack, Gap</p>
<p>Remarks Rear Seat - Grime - Medium / (R) Front Seat - Grime - Medium / (L) Front Seat - Grime - Medium / (L) Front Floor Mat - Cut, Crack - Small / (L) Front Floor Mat - Worked - Large / (L) Front Trim - Grime - Small / (R) Front Trim - Grime - Minimal / Ceiling - Grime - Minimal</p>	<p>Remarks (R) Front Fender, Molding - Scratch - Minimal / (R) Rear Door, Molding - Scratch - Small / (R) Front Door, Molding - Scratch - Minimal / (R) Side Gate - Scratch - Small / Rear Bumper, Lamps, Panels - Scratch - Medium / Rear Gate - Scratch - Minimal / Cargo Bed Floor - Modified - Medium / (R) Side Gate - Modified - Medium / (L) Side Gate - Modified - Medium / (L) Side Gate - Scratch - Large / (L) Rear Door, Molding - Scratch - Small / (L) Front Door, Molding - Scratch - Small / (L) Front Fender, Molding - Scratch - Small / Member (Bolted) - Dent - Yes / Front Bumper, Grille, Lamps - Scratch & Dent - Medium / Bonnet, Headlight - Scratch - Small / Roof - Scratch - Minimal</p>
