General Information

Make	Toyota	Model	Vios
YOM	2024	Odo Meter Reading	38,126
Registration No.	NHS2640	Chassis No.	PA1B18F33R4259310
CC	1.3	Transmission	CVT
Fuel Type	Gas	Type of Body	Sedan
Colour	Black

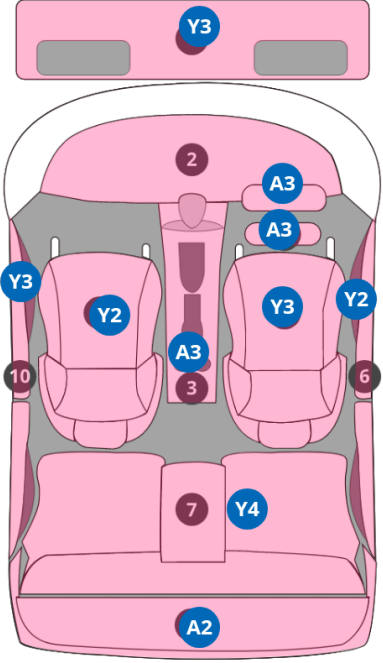
Interior Evaluation : D	Exterior Evaluation : D

<p>a : Cut, Fray d : Loose, Deformed k : Animal Hair s : Smell t : Cigarette Burns x : Defective y : Stain</p>

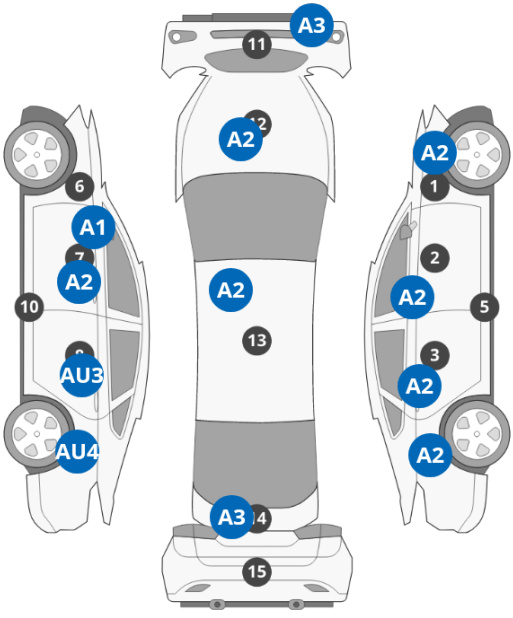
<p>A : Scratch AU : Scratch & Dent B : Modified C : Corrosion G : Stone chip P : Faded S : Rust SC : Rust & Corrosion U : Dent X : Defective Y : Crack, Gap</p>
<p>Remarks (R) Front Seat - Grime - Medium / (R) Front Trim - Grime - Small / Rear Seat - Grime - Large / Trunk Room - Worn, Scratch, Cut, Crack - Small / (L) Front Trim - Grime - Medium / (L) Front Floor Mat - Cut, Crack - Medium / (L) Front Seat - Grime - Small / Console, Switches, Vents - Worn, Scratch, Cut, Crack - Medium / Steering Wheel - Worn, Peel, Crack - Medium / Ceiling - Grime - Medium</p>	<p>Remarks Trunk Hood, Rear Gate - Repair Traces - Yes / (L) Rear Fender, Molding - Scratch & Dent - Large / (L) Step, In-panel, Side Spoiler - Scratch & Dent - Medium / (L) Front Door, Molding - Scratch - Small / (L) Mirror - Scratch - Minimal / Bonnet, Headlight - Scratch - Small / Front Bumper, Grille, Lamps - Scratch - Medium / (R) Front Fender, Molding - Scratch - Small / (R) Front Door, Molding - Scratch - Small / (R) Rear Door, Molding - Scratch - Small / (R) Rear Fender, Molding - Scratch - Small / Trunk Hood, Rear Gate - Scratch - Medium / Roof - Scratch - Small</p>
