## General Information

| Make | Nissan | Model | NV350 |
| Registration No. | NEA9274 | Chassis No. | JNT1C2E26Z0054301 |

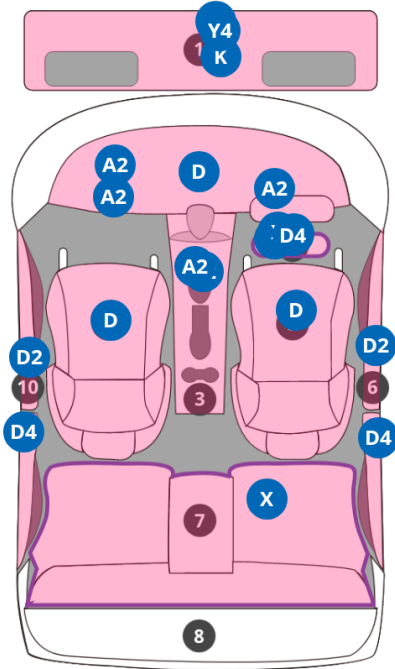
| Interior Evaluation : <b>E</b> | Exterior Evaluation : <b>E</b> |
| <p><b>Remarks</b></p> <p>Overall Interior - Smell - Yes / Overall Interior - Worn as per age - Yes / Overall Interior - Animal Hair - Yes / Ceiling - Grime - Large / (L) Front Floor Mat - Missing - Yes / (R) Front Floor Mat - Missing - Yes / Mat Other - Missing - Yes / (R) Front Seat - Worn - Yes / (L) Front Seat - Worn - Yes / Console, Switches, Vents - Worn, Scratch, Cut, Crack - Small / Dashboard - Traces of Adhesive Tape - Yes / Dashboard - Worn, Scratch, Cut, Crack - Small / Steering Wheel - Worn, Peel, Crack - Small / Glove Box - Worn, Scratch, Cut, Crack - Small / Knobs - Worn, Peel, Crack - Small / Room Mirror - Stuck - Yes / Display, Audio System - Stuck - Yes / (L) Front Trim - Worked - Small / (R) Front Trim - Worked - Small / (L) Rear Trim - Worked - Large / (R) Rear Trim - Worked - Large / Rear Seat - Missing - Yes / Carpet - Worked - Large</p> | <p><b>Remarks</b></p> <p>Trunk Hood, Rear Gate - Repair Traces - Yes / Front Panel - Scratch &amp; Dent - Medium / Trunk Hood, Rear Gate - Repair mark - Yes / Front Bumper, Grille, Lamps - Scratch - Large / (R) Front Door, Molding - Scratch &amp; Dent - Medium / (R) Front Fender, Molding - Scratch - Small / (R) Mirror - Scratch - Minimal / (R) Step, In-panel, Side Spoiler - Scratch &amp; Dent - Large / (R) Rear Door, Molding - Scratch &amp; Dent - Large / (R) Rear Fender, Molding - Scratch &amp; Dent - Large / Rear Bumper, Lamps, Panels - Scratch - Large / Trunk Hood, Rear Gate - Scratch &amp; Dent - Large / (L) Rear Fender, Molding - Scratch &amp; Dent - Large / (L) Front Door, Molding - Scratch &amp; Dent - Small / (L) Front Fender, Molding - Scratch - Small / (L) Mirror - Scratch - Minimal / Roof - Scratch - Medium</p> |
