## General Information

| <b>Make</b> | Toyota | <b>Model</b> | Vios |
| <b>YOM</b> | 2025 | <b>Odo Meter Reading</b> | 34,087 |
| <b>Registration No.</b> | FAQ8025 | <b>Chassis No.</b> | PA1B18F33R4268749 |

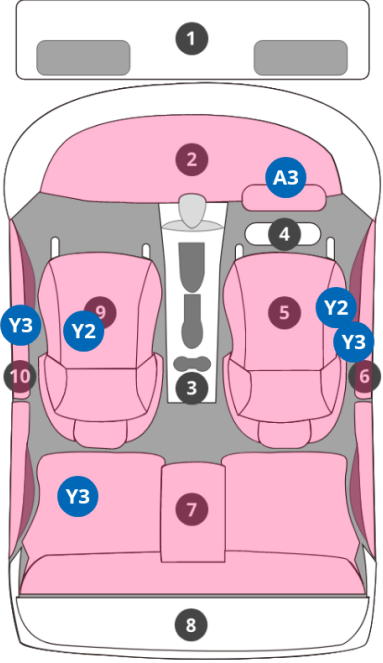
| <b>Interior Evaluation :</b> <span style="float: right; color: red; font-weight: bold;">C</span> | <b>Exterior Evaluation :</b> <span style="float: right; color: red; font-weight: bold;">C</span> |

| <p><b>Remarks</b><br/>Steering Wheel - Worn, Peel, Crack - Medium / (L) Front Trim - Grime - Medium / Rear Seat - Grime - Medium / (R) Front Trim - Grime - Medium / (R) Front Seat - Grime - Small / (L) Front Seat - Grime - Small</p> | <p><b>Remarks</b><br/>(R) Rear Door - Repair Traces - Yes / Front Bumper, Grille, Lamps - Scratch &amp; Dent - Medium / (R) Front Fender, Molding - Scratch - Medium / Bonnet, Headlight - Scratch - Small / Roof - Scratch - Minimal / (L) Front Door, Molding - Dent - Small / Trunk Hood, Rear Gate - Scratch - Small / (L) Rear Door, Molding - Scratch - Minimal / Rear Bumper, Lamps, Panels - Scratch - Minimal / (R) Rear Door, Molding - Scratch - Small / (R) Rear Fender, Molding - Scratch - Medium</p> |
